Never too late for dowels or tie-bars

the techniques of dowel bar retrofitting and cross stitching

Pascal Buys ROBUCO

EUPAVE Best Practices Workshop

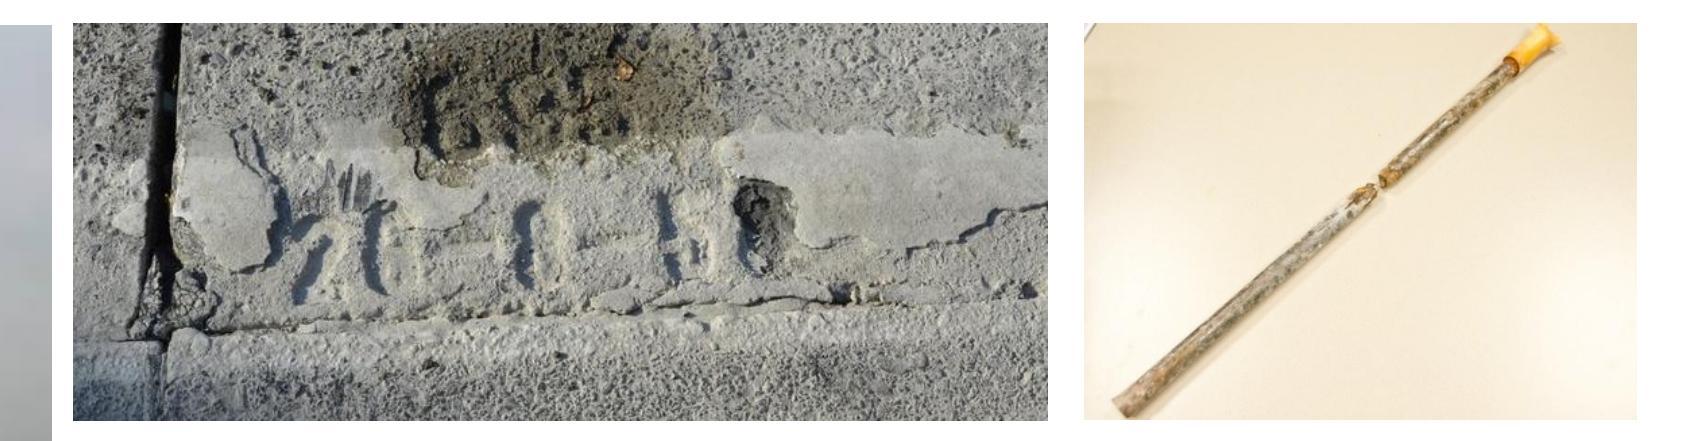
Dowel bar retrofitting at regional road N44 in Aalter

- Old JPCP built in 1958
- BRRC: Measurement of slab faulting and load transfer at joints
- Slab stabilisation by injection with a cement mortar

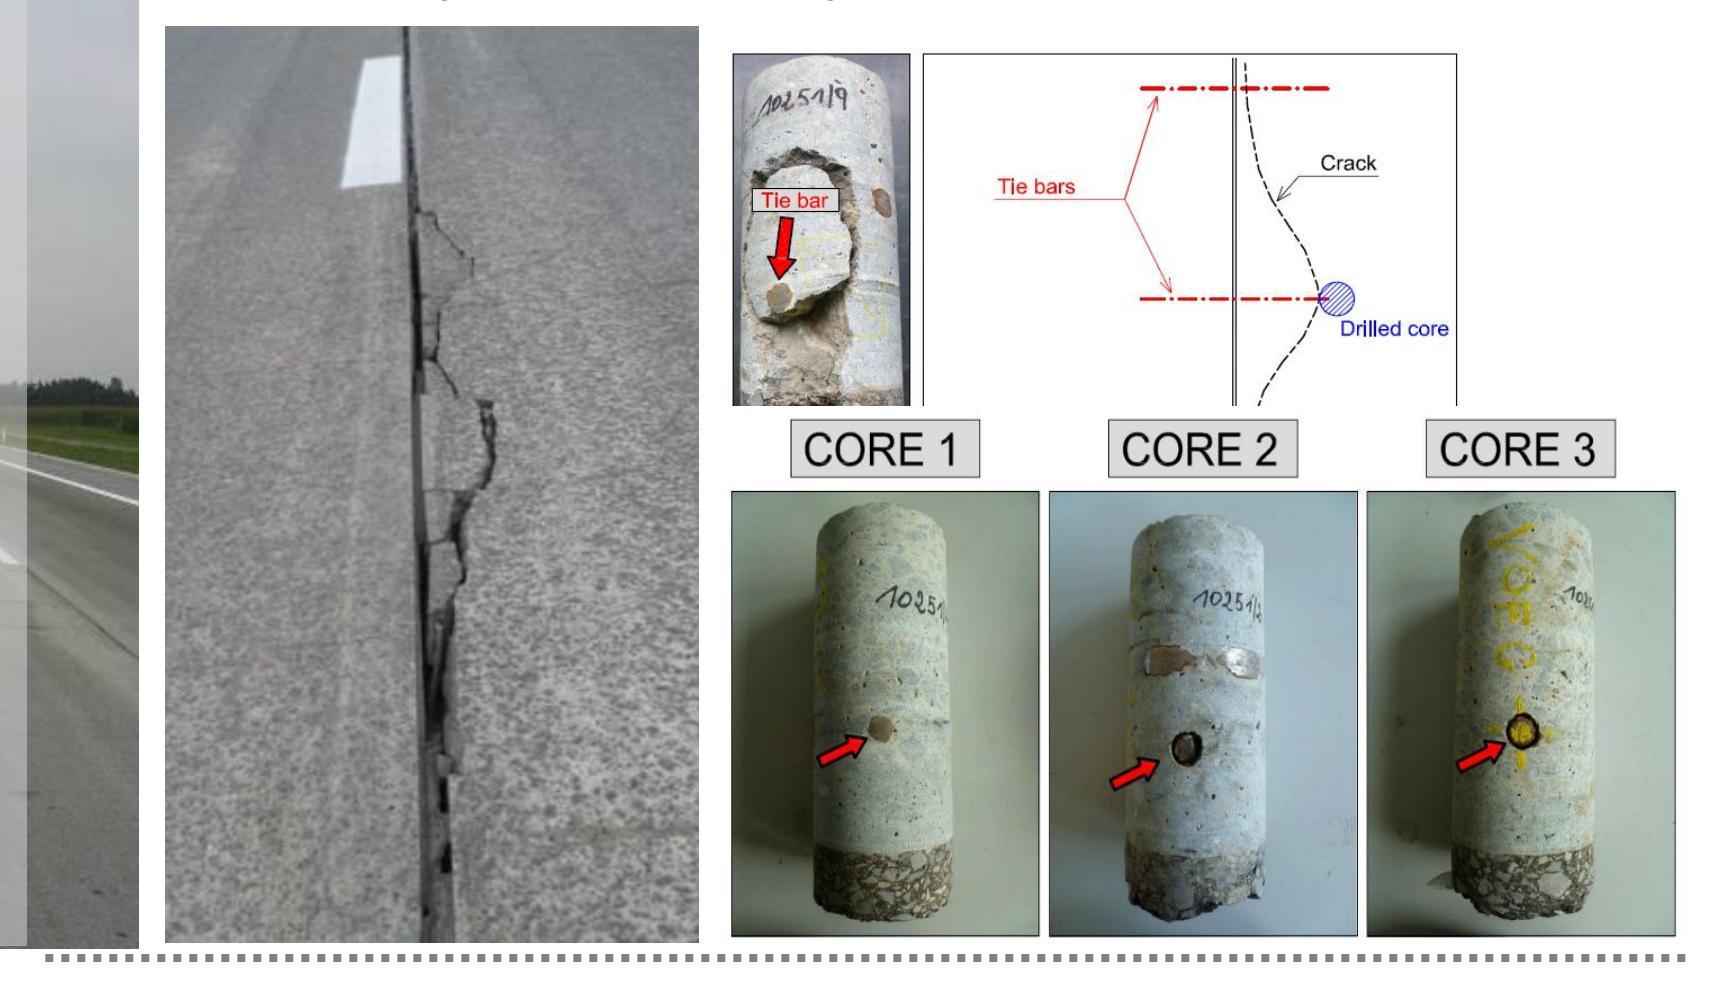
Longitudinal cracks along the joint

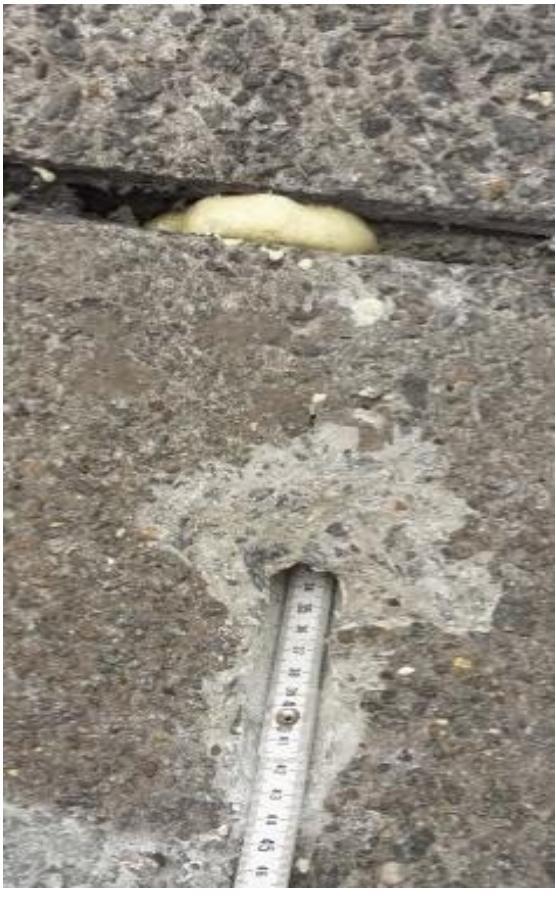
Presence of longitudinal reinforcement bar near to the edge made it difficult to drill the hole

Drilling the holes

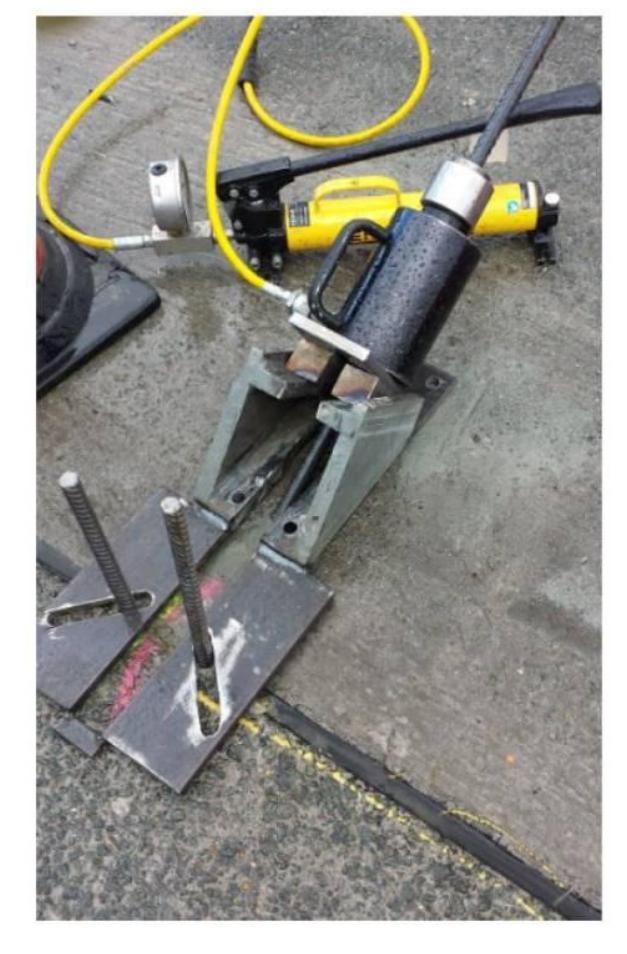
Pull-out test of tie bar

In specifications: min. 50 kN tensile force
Up to 100 kN – no rupture
