# Road auscultation and condition assessment

ANNE BEELDENS

AB-ROADS

14/10/2020

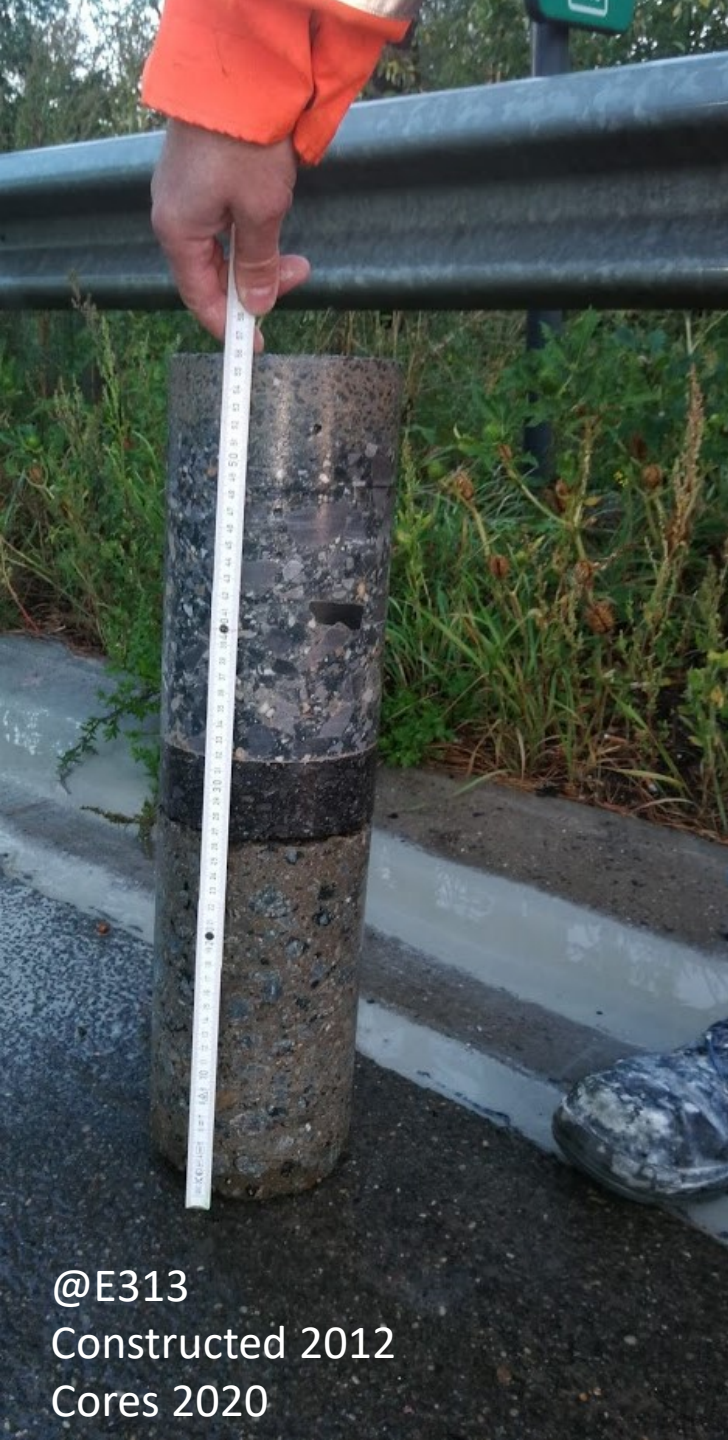
@E313  
Constructed 2012  
Cores 2020

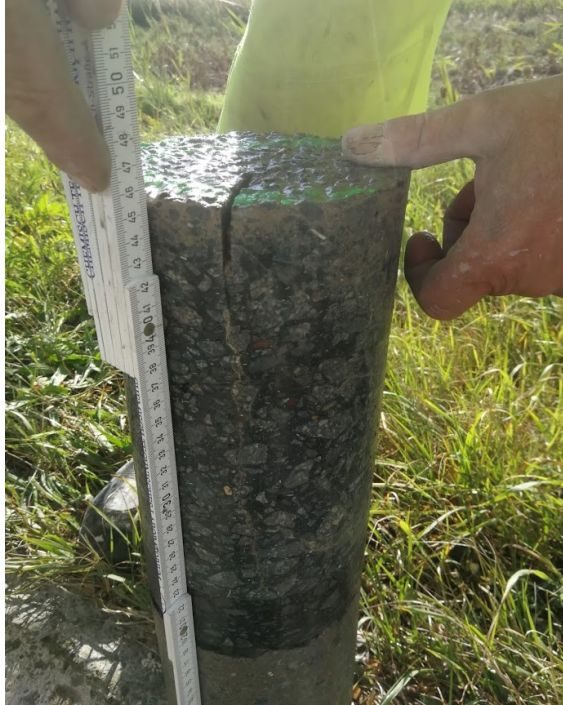
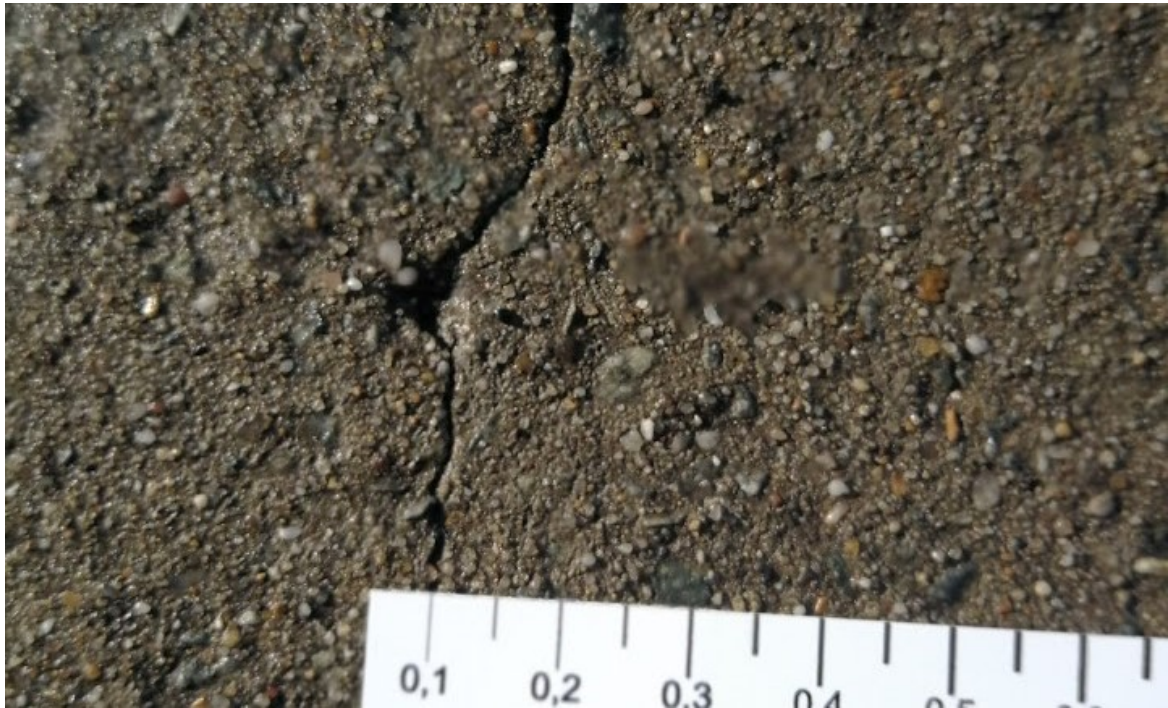
$\leq 0,4 \text{ mm}$  to  $0,5 \text{ mm}$

At which height?

How to measure at the surface,  
especially with exposed  
aggregate surface?

=> design parameter but not a  
valid parameter for on site  
evaluation

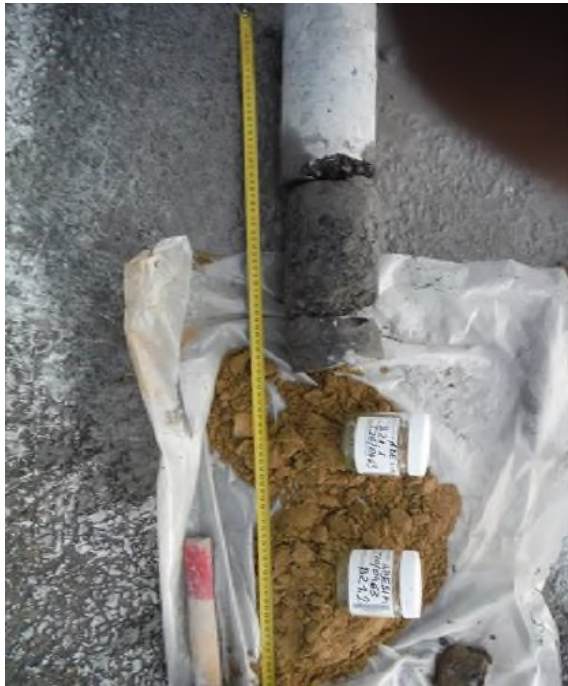
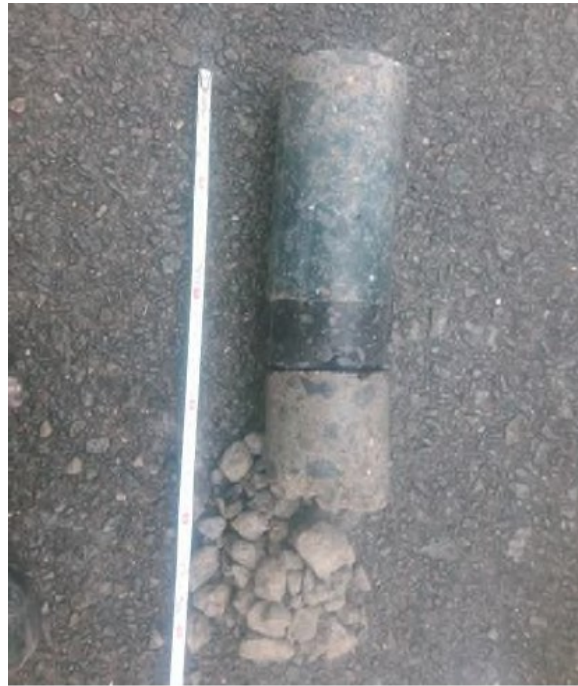
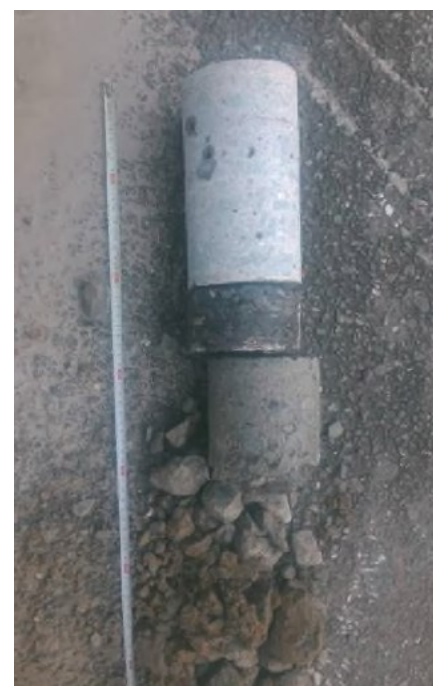
200 mm CRCP – 60 mm asphalt interlayer – 250 mm lean concrete – 200 mm coarse sand – 300 mm fine sand

Construction: 2003 CRCP and ABT, lean concrete: 2003 or older...

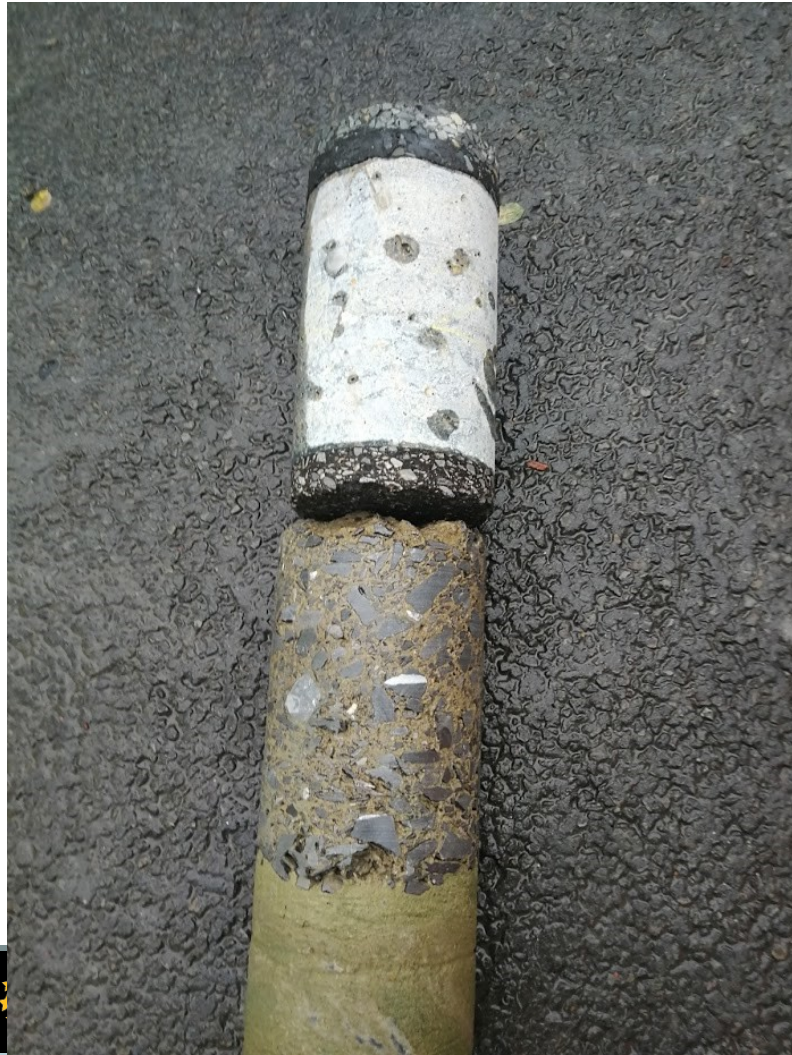
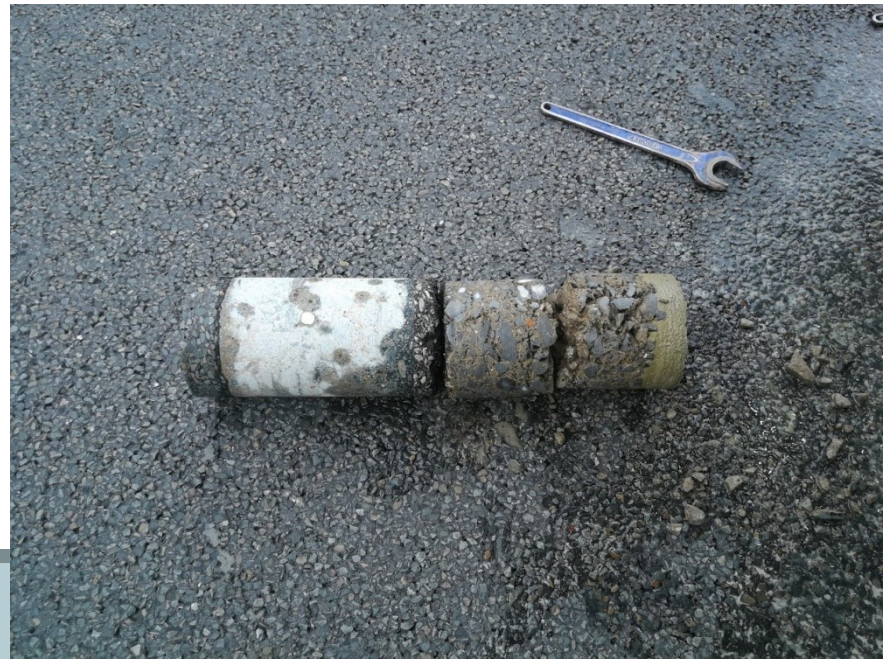
# Example: E40, constructed in 1971-1972, overlaid in 2007, core drilled in September 2020

Degradation: erosion + locally fatigue (or quality) of base layer

Quality of base layer!

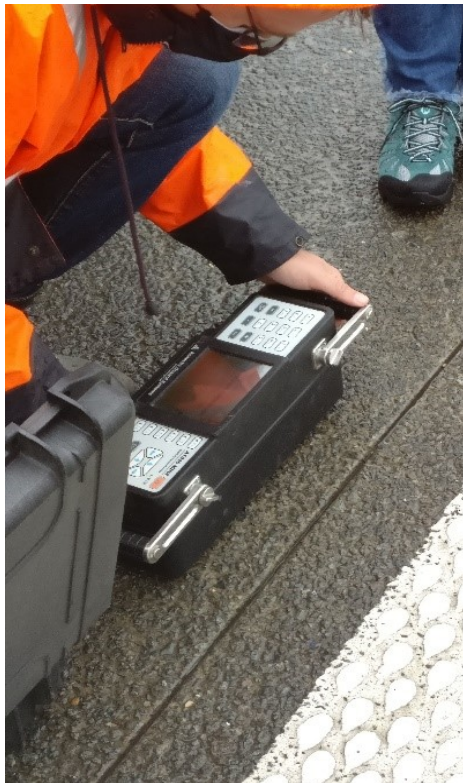
In the concrete pavement: ultrasonic tomograph

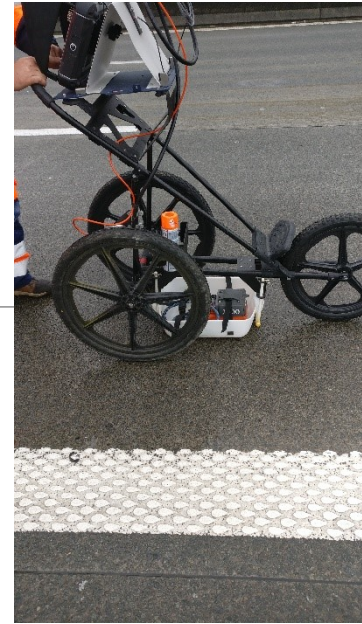
Over the whole structure: georadar

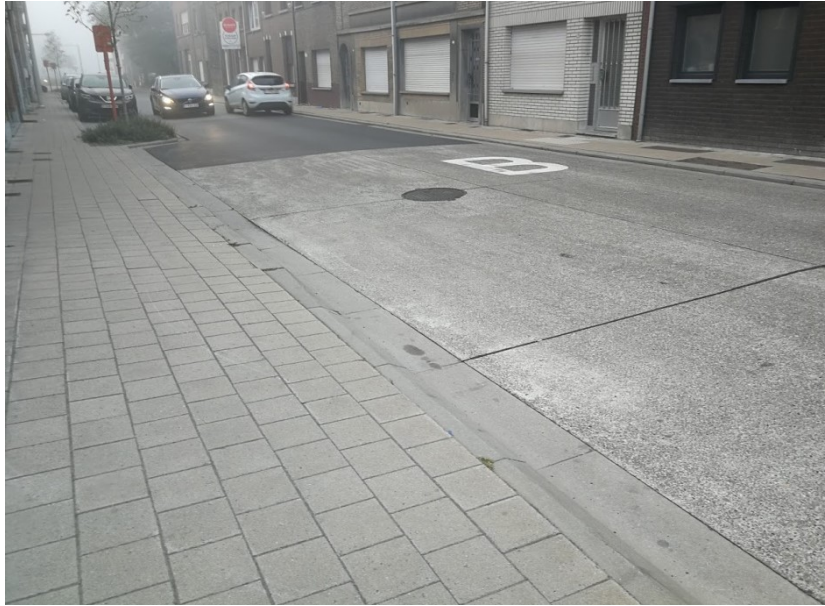
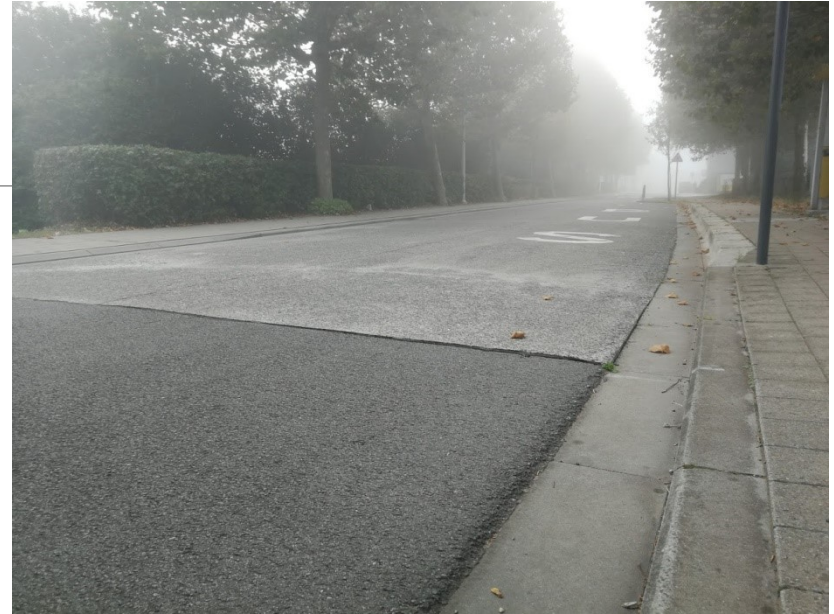
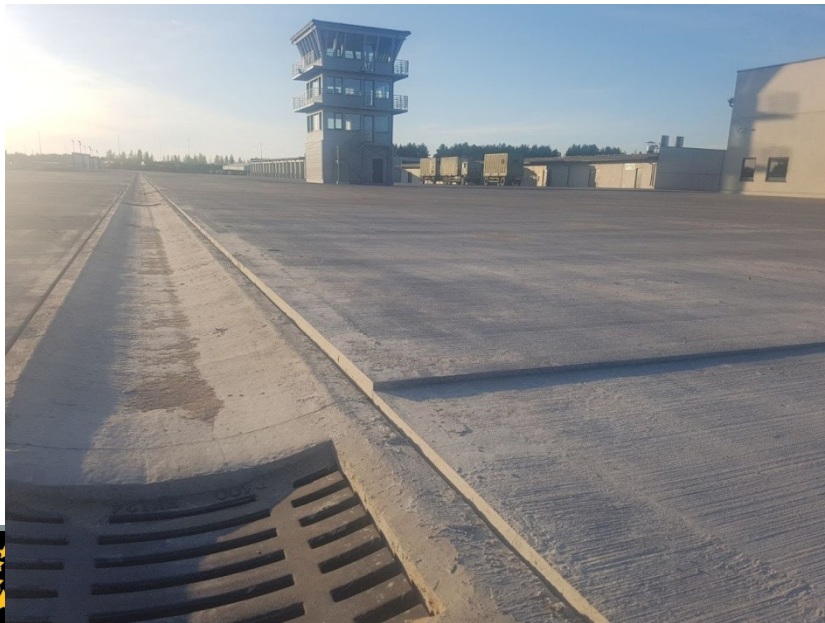
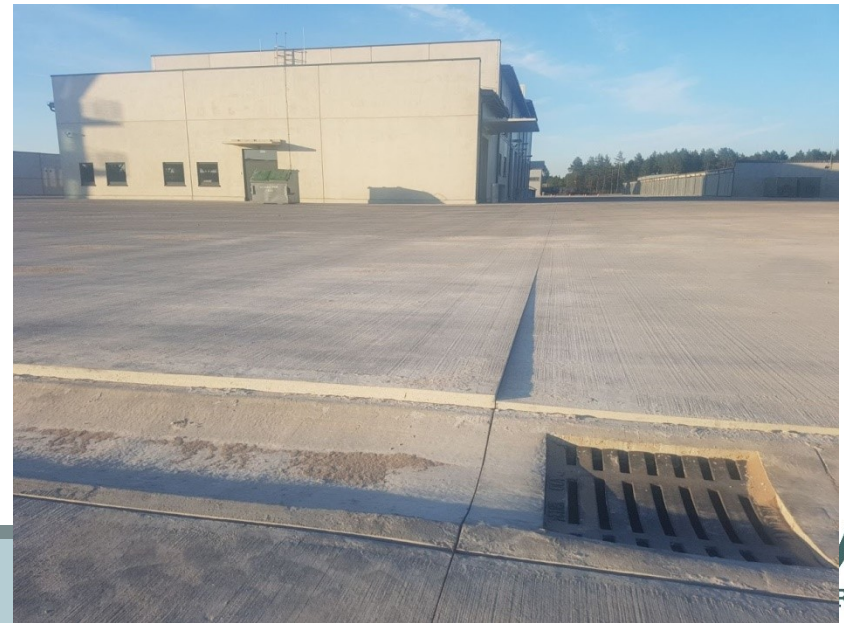
# JPCP - Curling due to temperature differences or moisture differences or internal curling

New constructed JPCP without dowels on a cement treated base or subbase layer in a town centre

=> complaints of vibrations

Measurement of faulting of slabs and measuring of vibrations in houses, results strongly depend on type of foundations of houses

Importance of dowels and asphalt interlayer in order to prevent curling

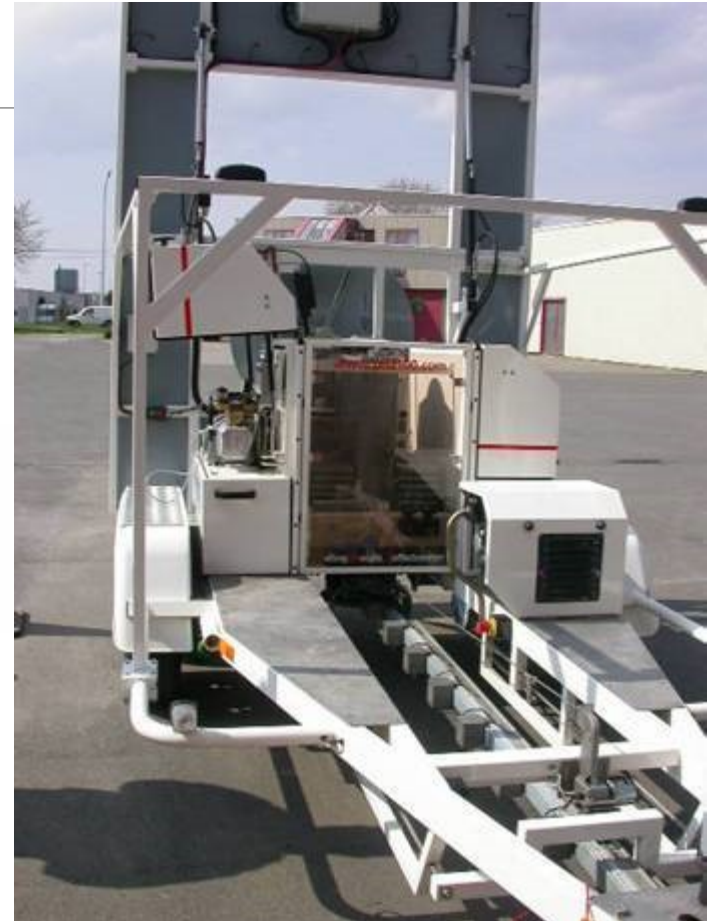
# Falling weight deflectometer (FWD) – bearing capacity and load transfer

Static

Non-destructive

Deflection

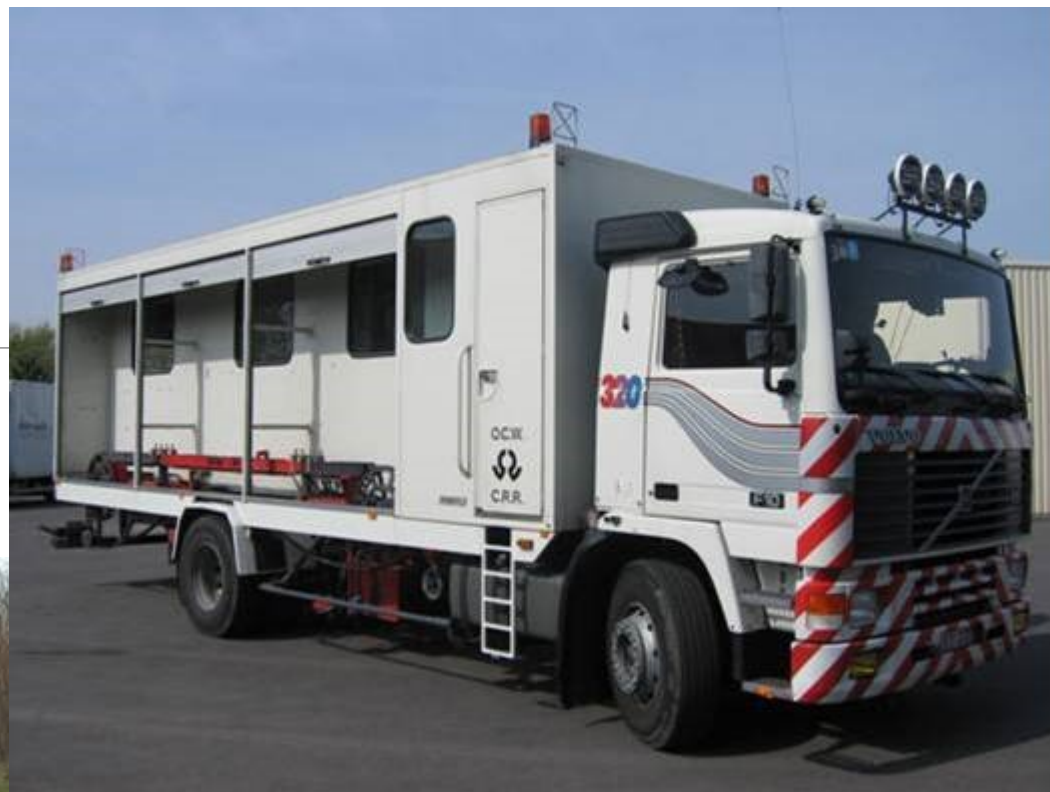
*Curviameter: with traffic*

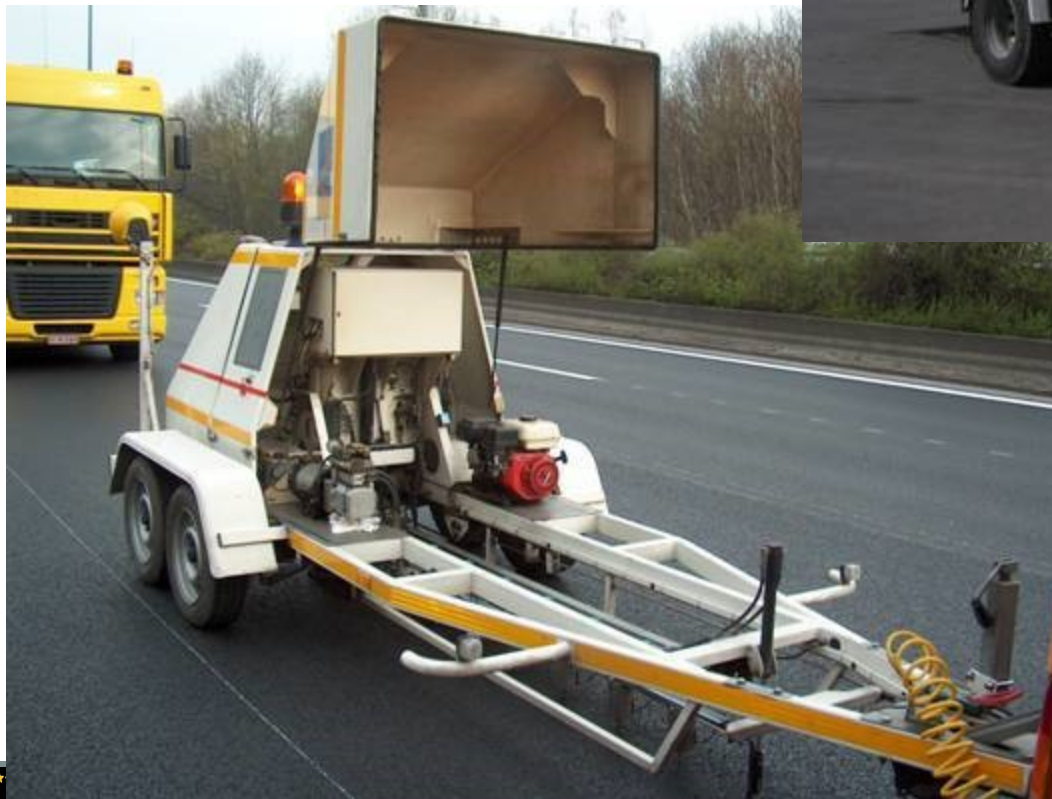
*Falling weight deflectometer*

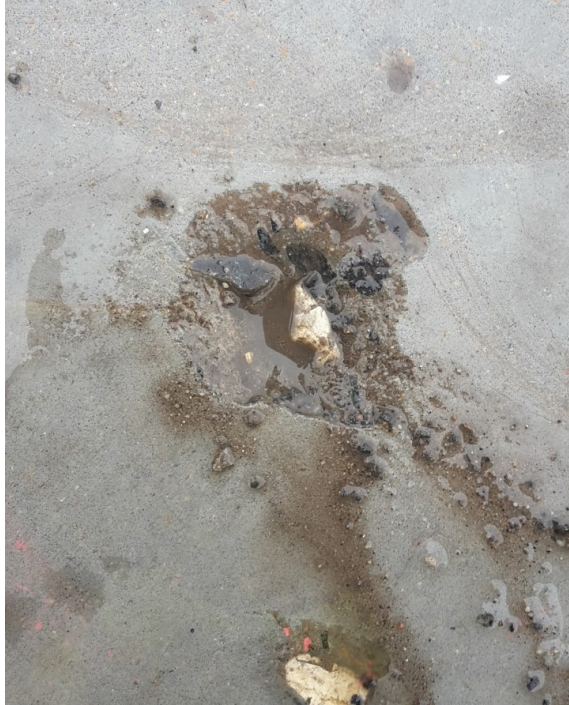
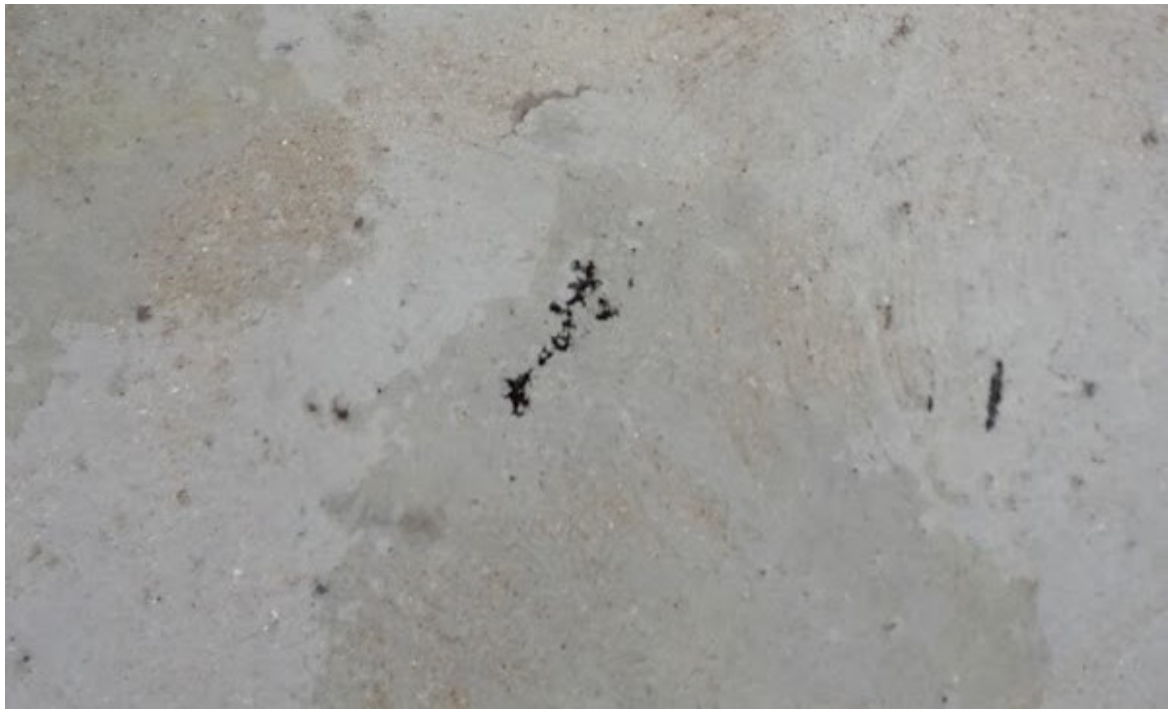
No frost resistant  
aggregates:  
pop-outs

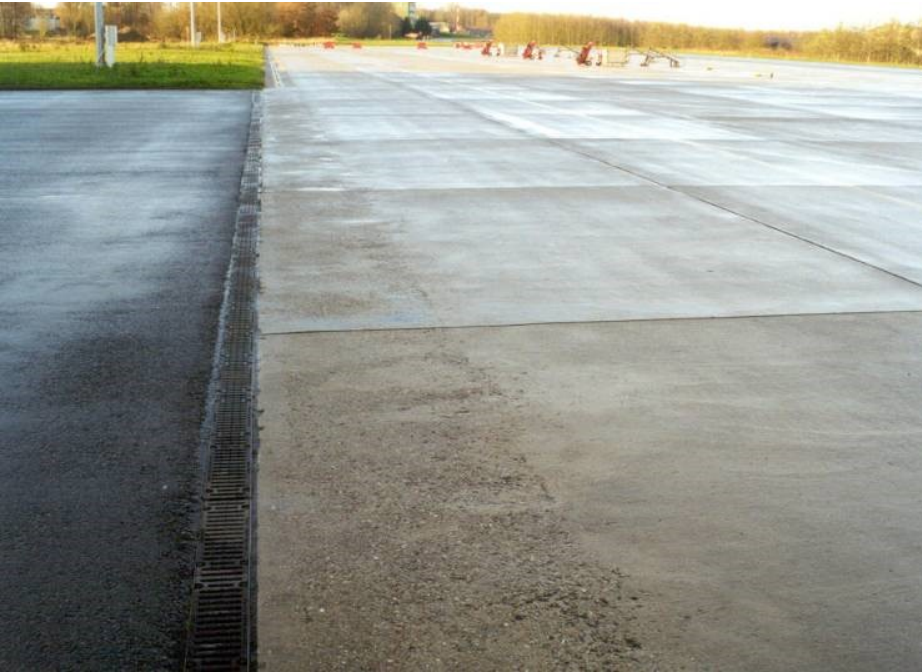
Testing of concrete on drilled cores

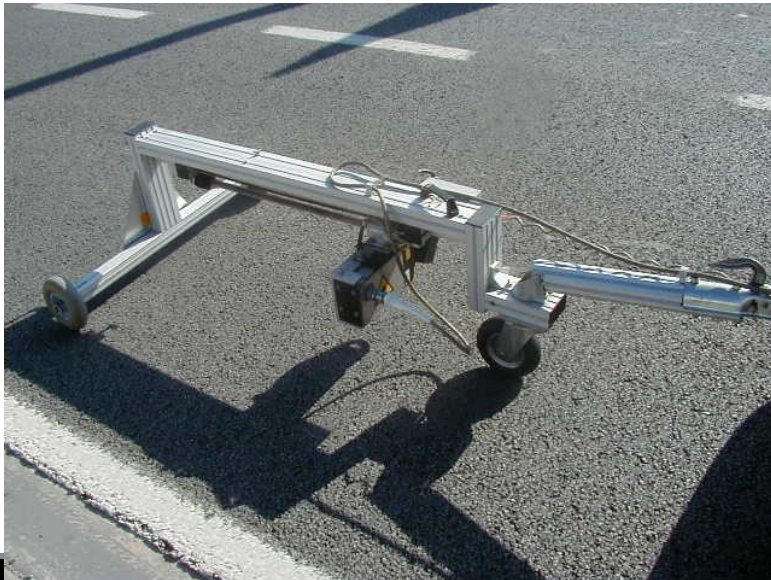
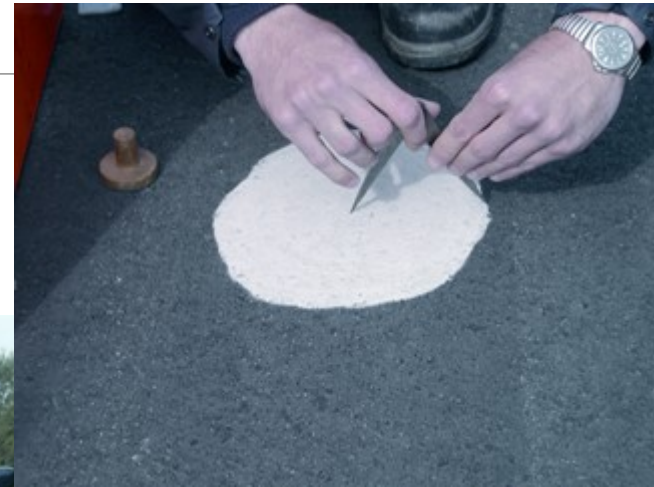
*Laser profilometer*

Texture is determined by the MPD (mean profile depth)

- MPD: 0,7/0,8 (two layered/one layered) to 1,5

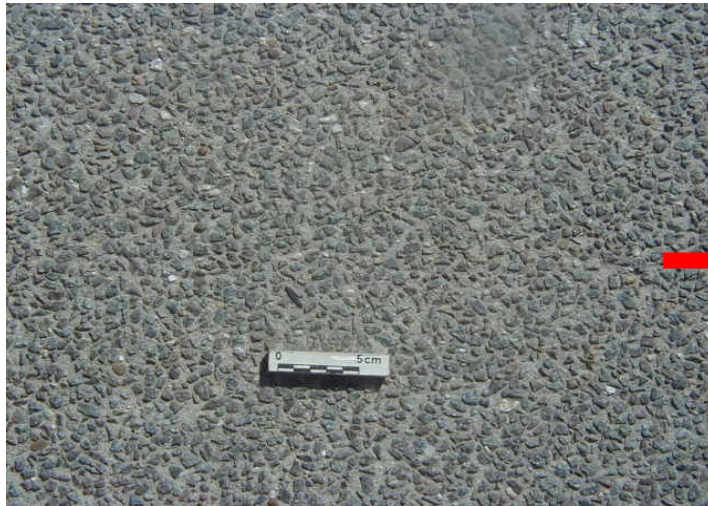
Exposed aggregate concrete 0/6

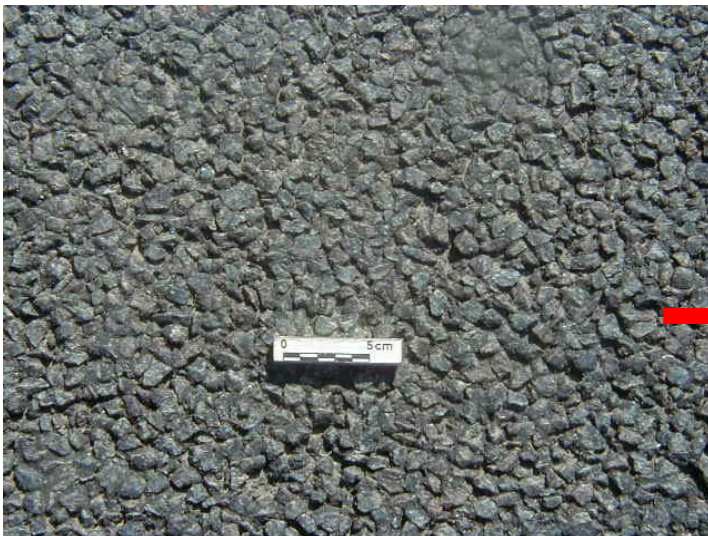
Porous concrete 0/14

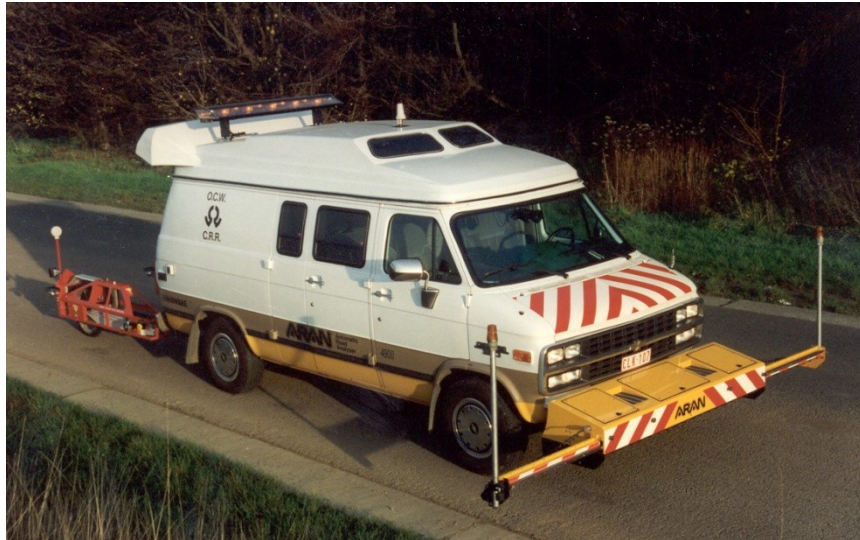
# Transverse evenness: measurement with ARAN (automatic road analyser)

Gyroscopen: roll, pitch, yaw

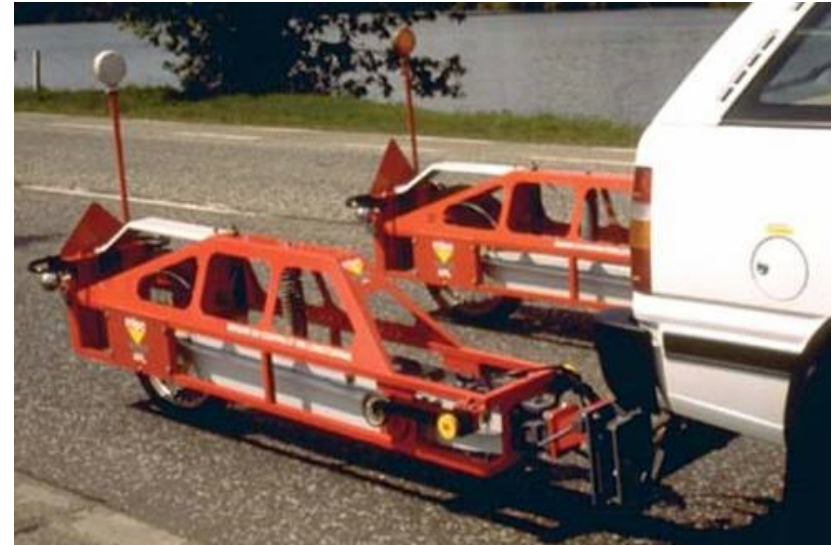
# Longitudinal evenness – directly after the slipform paver or as condition assessment

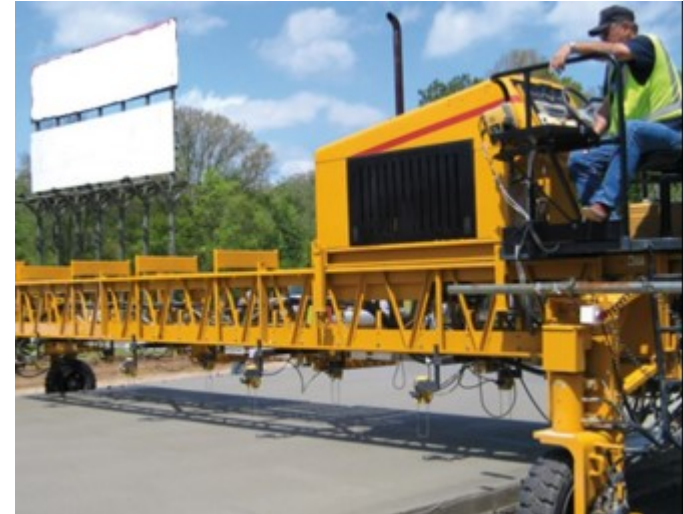
Real-time evenness measurements  
on slipform paver or directly after  
slipform paver
