# Durable repair and rehabilitation of CRCP

Elia Boonen – Belgian Road Research Centre (BRRC)

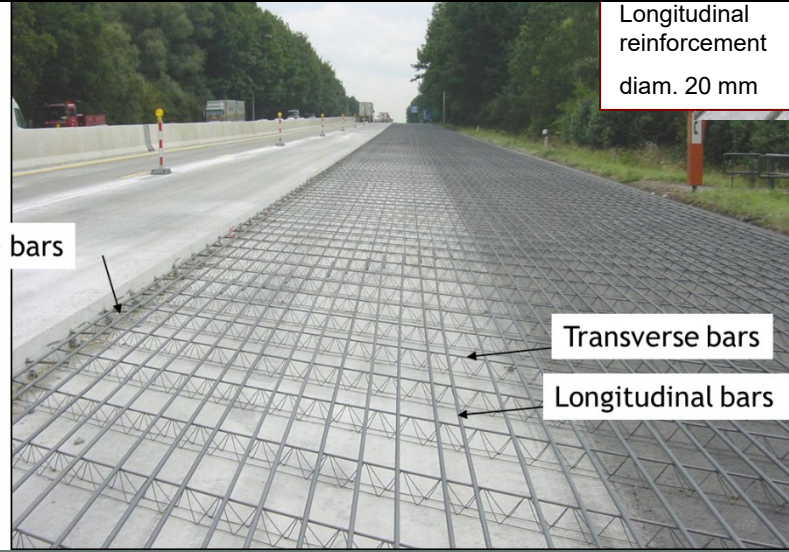
( )	( )		
16	16	20	20	20
130±20	130±20	180±20	180±20	170±20
90	100	100	120	130
12	14	14	12	14
80±10	80±10	80±10	80±10	80±10
70 à 90			80 à 100	80 à 100
80±10	80±10	80±10	80±10	80±10

Longitudinal reinforcement  
diam. 20 mm

Transverse reinforcement  
diam. 14 mm

Splicing of the rebars  
35 x diameter (700 mm)

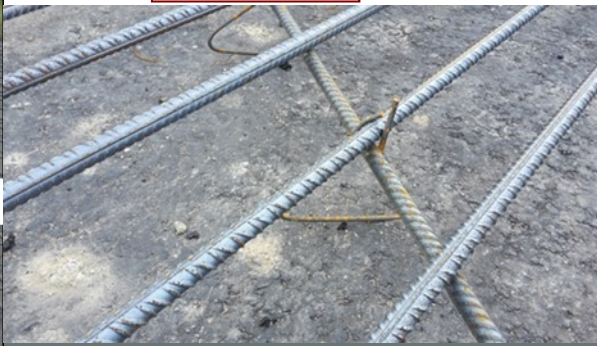
Two tied connections per splice

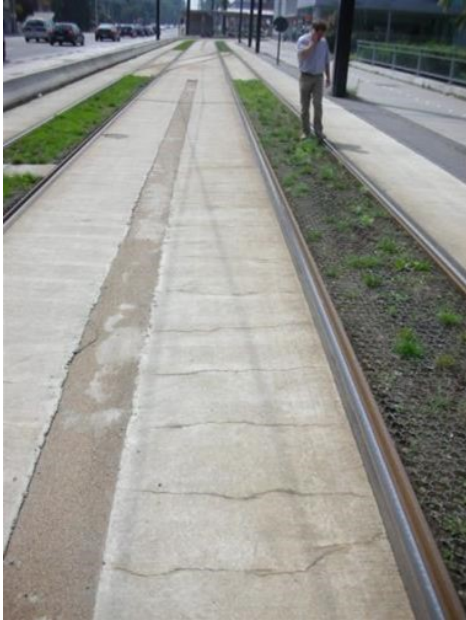
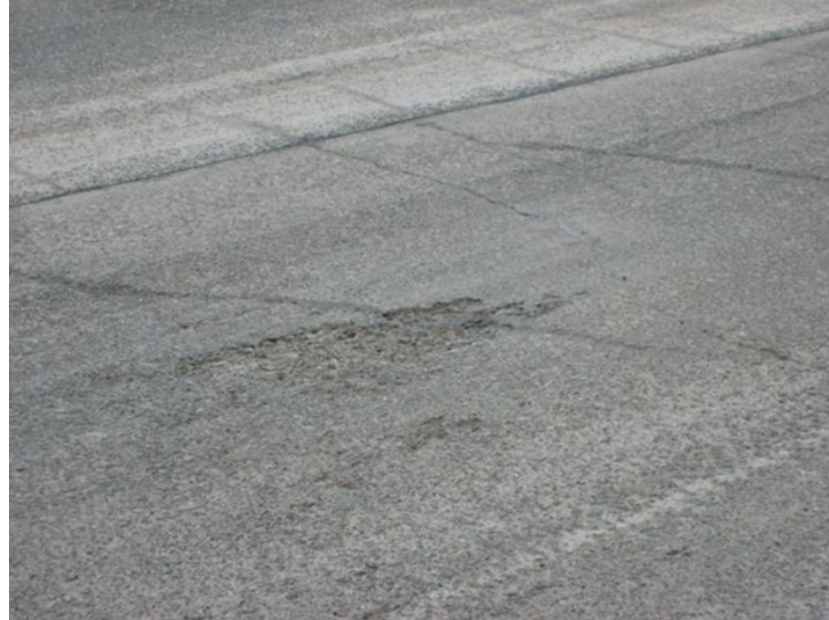
- Transverse cluster cracking
  - Weak concrete (w/c ratio, construction problems, etc.)

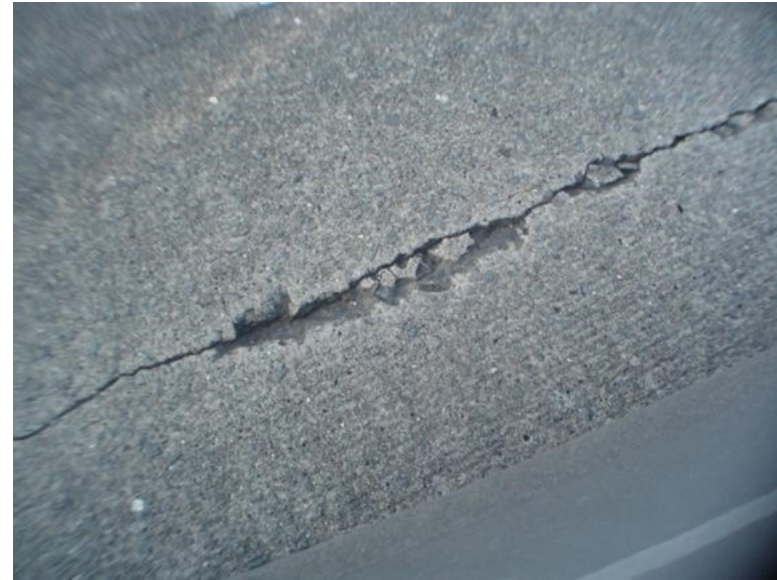
- Spalling of the cracks
  - From minor to severe
  - Transverse and sometimes longitudinal cracks
  - Inadequate tensile strength at the surface (bleeding, ...)
  - Number of spalled cracks increases with crack spacing

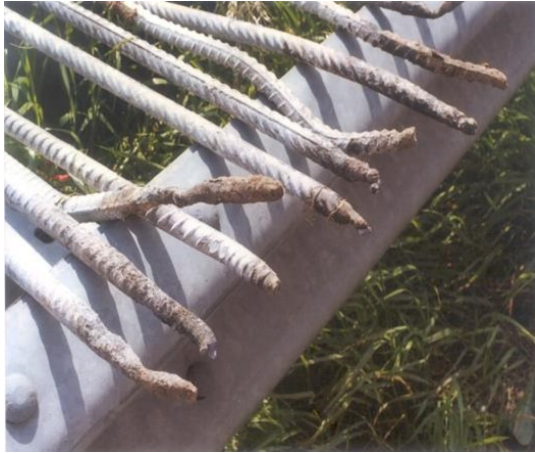
*Corroded reinforcement bars at transverse construction joint in CRCP*

- Steel rupture
  - Bad design: stress exceeds tensile strength of the steel
  - Corrosion (construction joints, deicing salts)

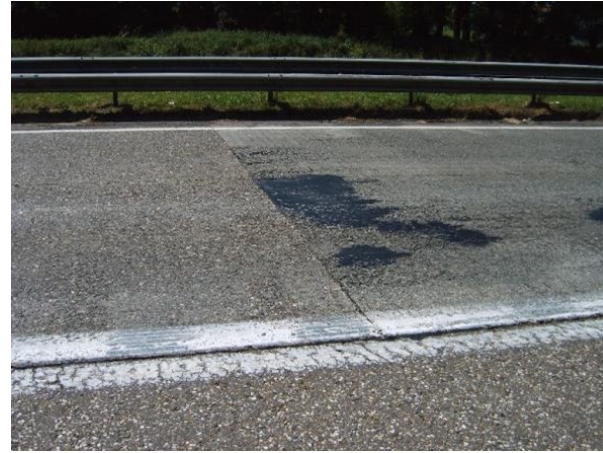
*Transverse construction joint in CRCP, with increased risk of water penetration*

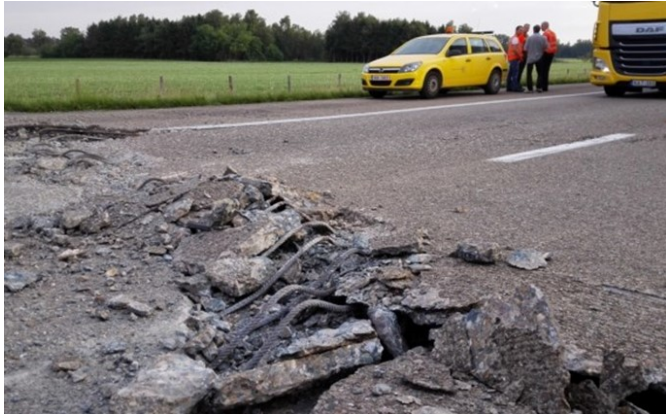
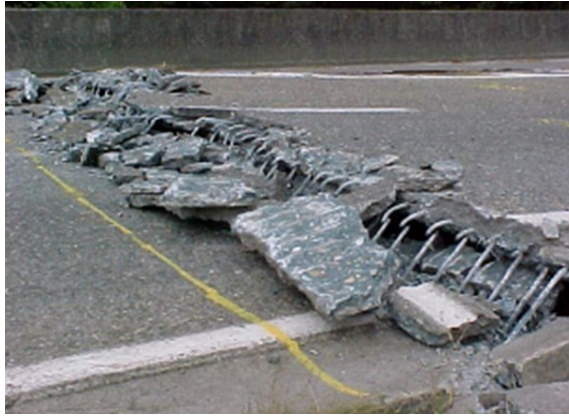
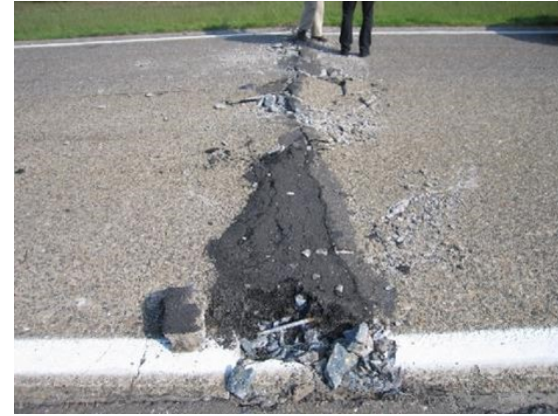
- “Blow-ups”
  - Bad compaction of the concrete at construction joints; poorly executed or maintained “day joint”
  - Discontinuities by earlier “temporary” repairs

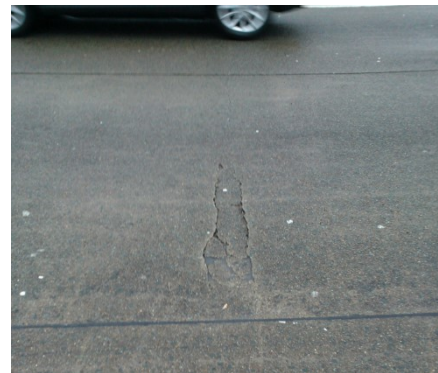
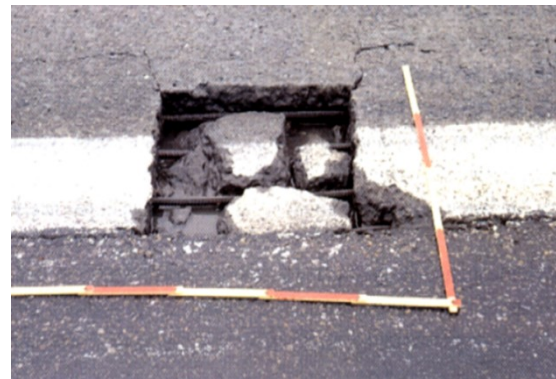
- *Punch-out* = most severe potential problem!

- Close spacing of transverse cracks (distance < 50 cm)
- Presence of water between CRCP and base layer
- Base layer sensitive to erosion
- Heavy and intense traffic near the slab edge (edge effect)

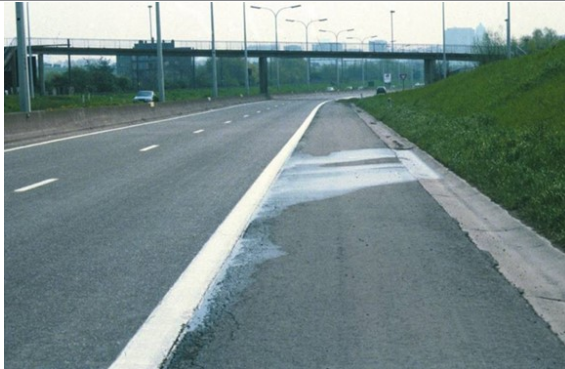
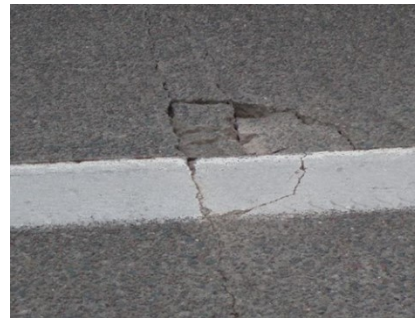
Expulsion of water with fine particles in case of base layer sensitive to erosion

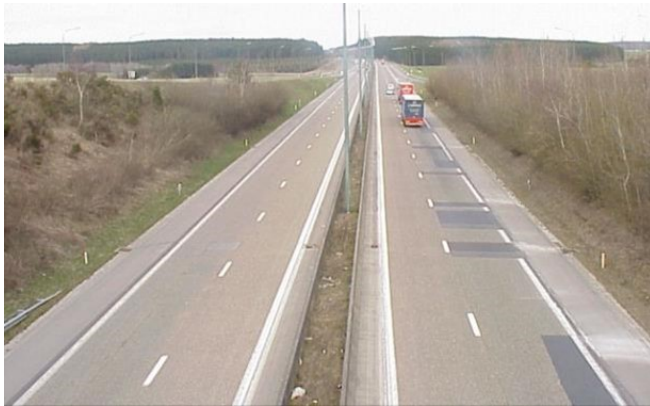
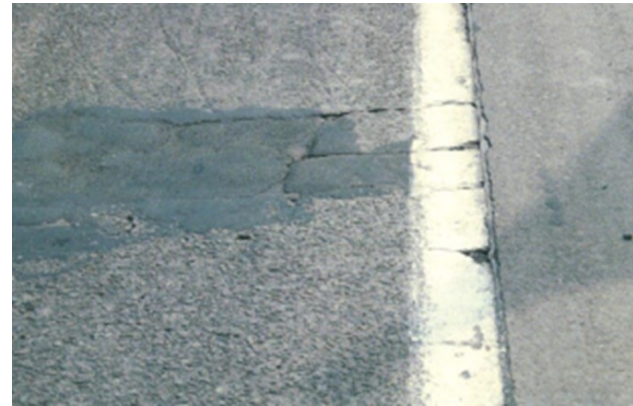
- Systematic loading of the longitudinal joint will inevitably lead to damage, either by the pumping effect, either by increased stresses
- True for longitudinal construction joints and longitudinal bending joints

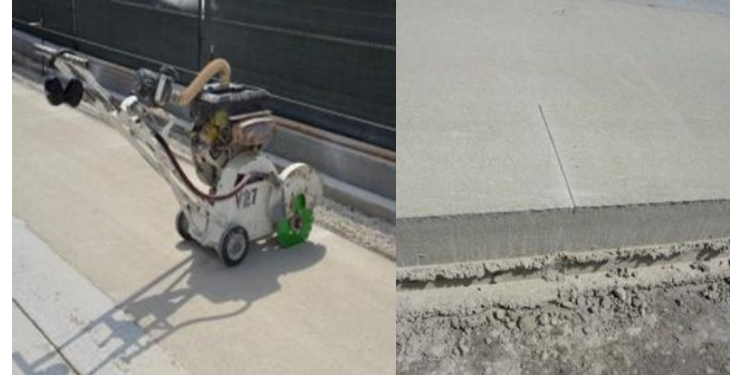
- Reinforcement percentage influences distribution and distance of cracks (in Belgium: 0.70-0.75 %, which leads to an average interdistance of  $\pm 1.0$  m)
- Elastic limit of reinforcement steel
- **New(er) method: active crack control**
  - Length: 40 cm
  - Spacing: 1.20 m
  - Depth: 4 cm
  - Saw cut: as soon as possible, within 24 hours after concreting

*Applied on E313, E17, A8, E420, A7, etc.*

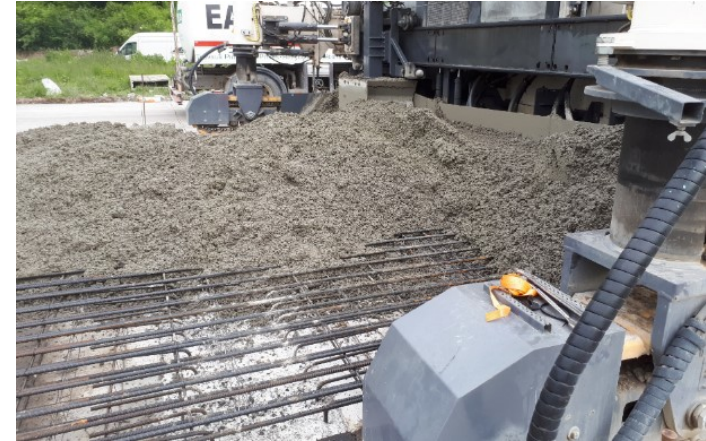
- Structural design: type, quality and thickness of the sub-base, base and concrete pavement
- Steel reinforcement: %, spacing, level
- Concrete mix quality
- Compaction
- Curing
- Drainage facilities
- Construction joint
  - Extra compaction with manual vibrating poker
  - Extra reinforcement
  - (Lower w/c or extra cement for first and last batches)

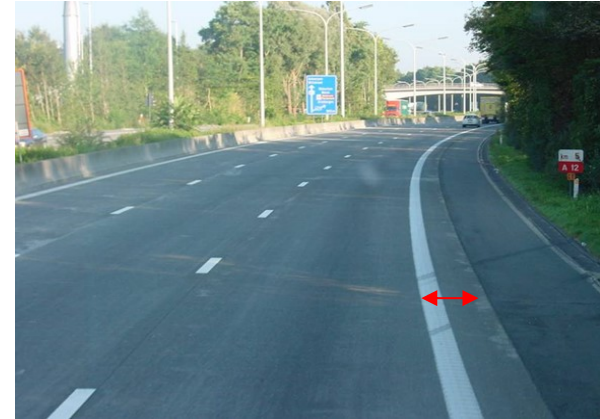
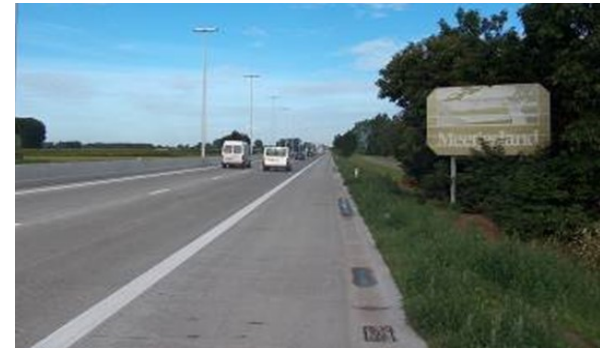
- Non erodible base layers; drainage
- Intermediate asphalt course between base and CRCP
- Extra width at the edge of the slow lane (marking at the inside)
- Executing hard shoulder and right-hand lane in one phase

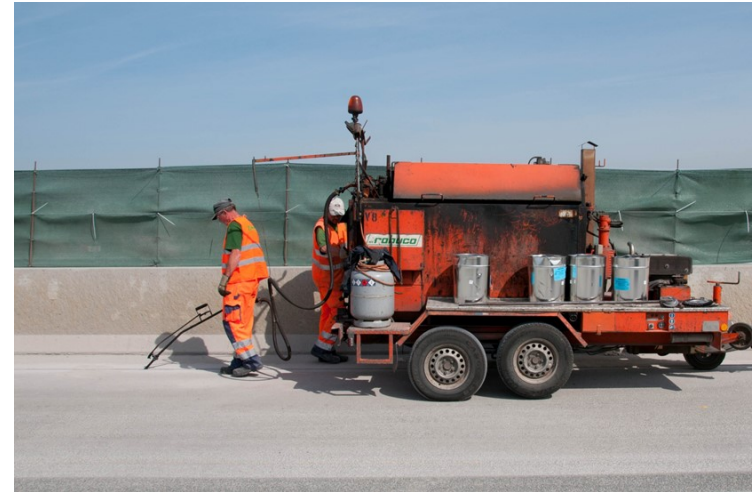
- Joint sealing
  - Construction joints
  - Longitudinal joints
    - Between lanes
    - Edge joints (shoulder)
- Crack sealing
  - Only for severely spalled cracks
- Drainage facilities

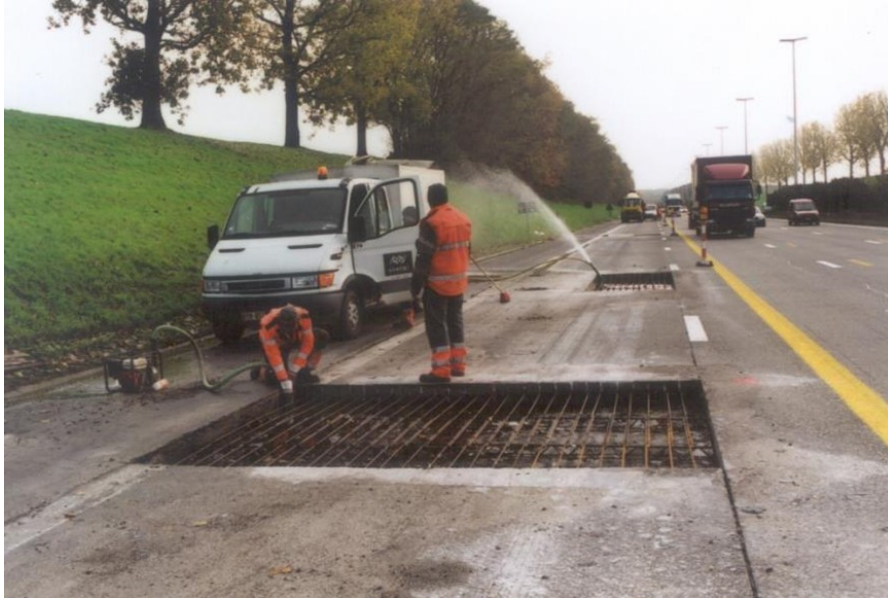
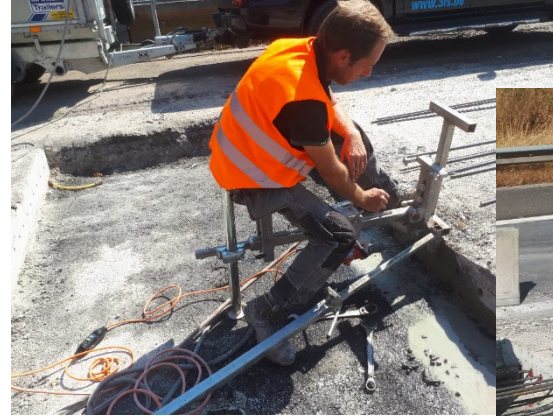
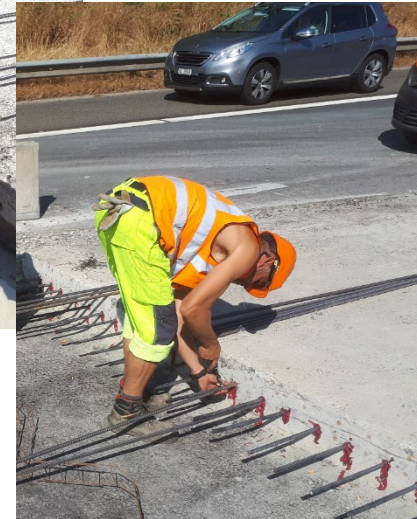
- **First method:** *drilling and chemical anchorage of reinforcement*

- Saw cuts over full depth, perpendicular to longitudinal joint
- Minimum dimensions: 1.50 m - Rectangular shape
- Repair of construction joint:
  - Minimum length 2 m (1 m at each side of joint)
  - Width  $\geq$  slab width (between 2 longitudinal joints)
- Restoration of the base or the intermediate asphalt layer, if needed
- Restoring the reinforcement:
  - 1) **By drilling and chemical anchorage of reinforcement**
  - 2) **By liberating the existing reinforcement**

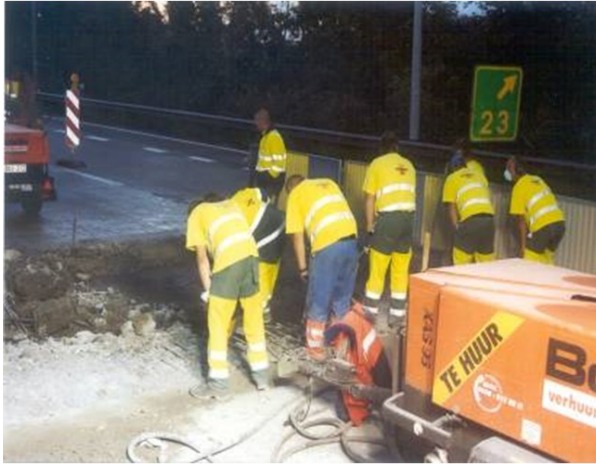
Saw cut at a depth of 4 cm

Longitudinal reinforcement kept in place

Vertical face on the existing concrete

Tied reinforcement splice

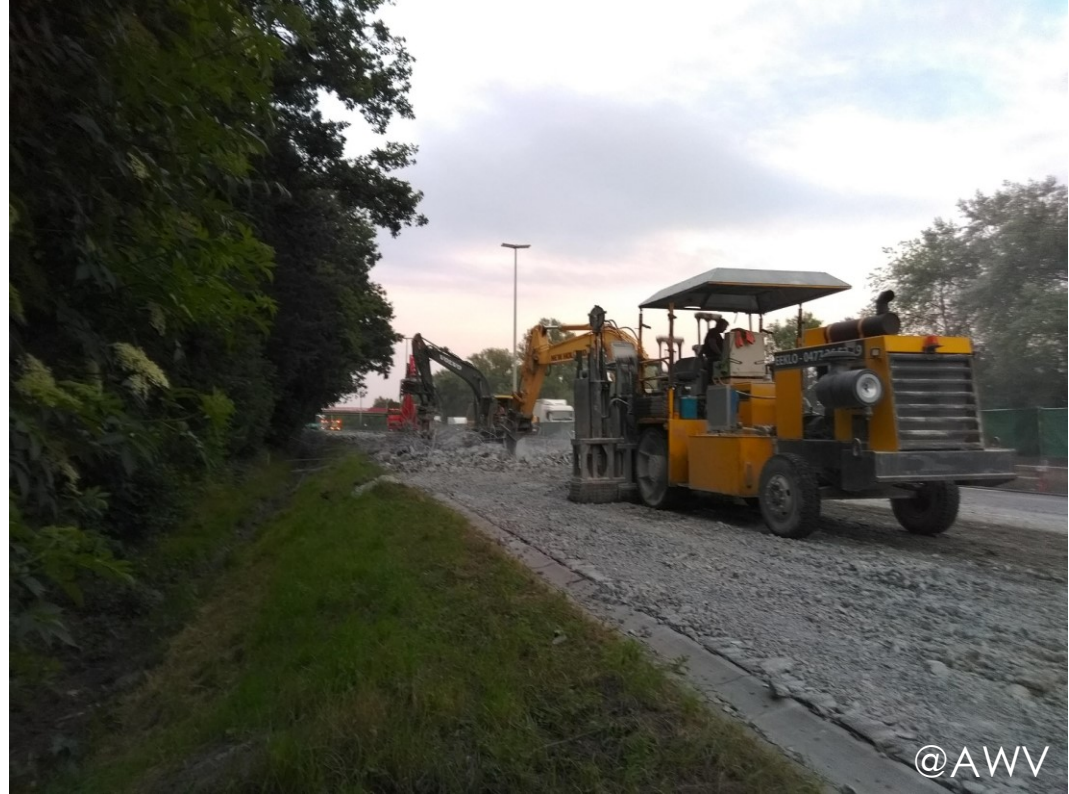
- Execution
  - Breaking of the concrete pavement

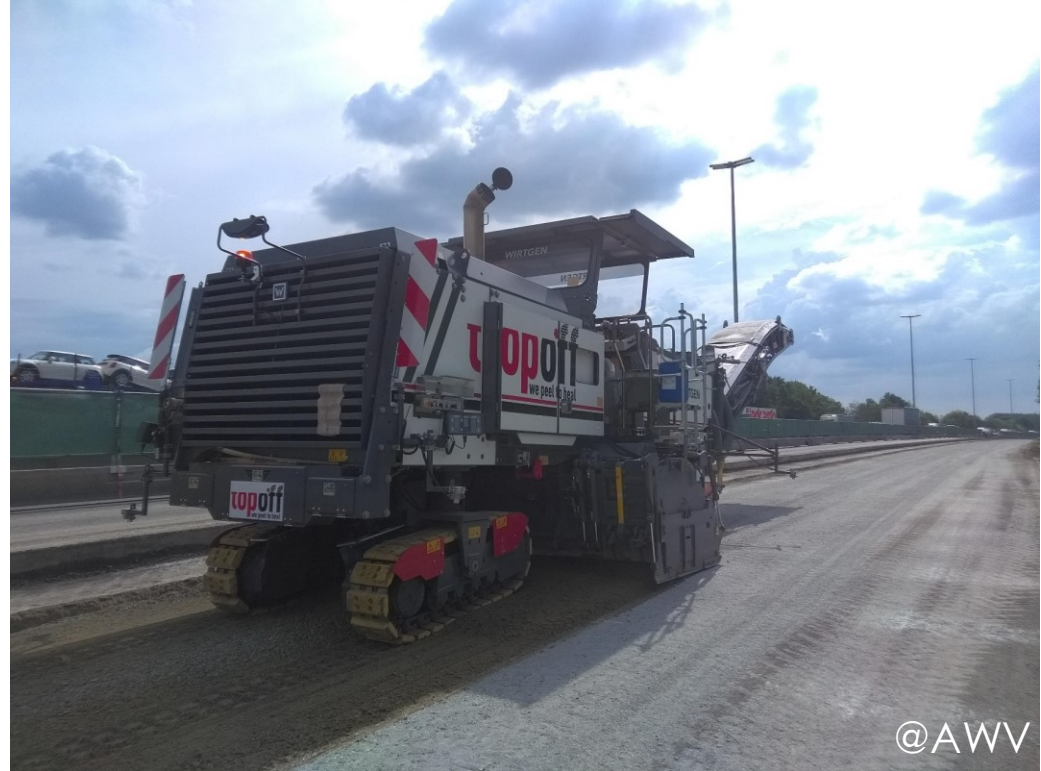
- Execution
  - Cold milling of existing asphalt layer

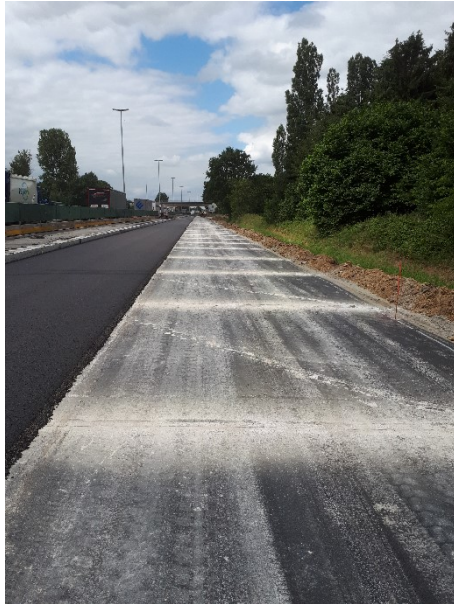
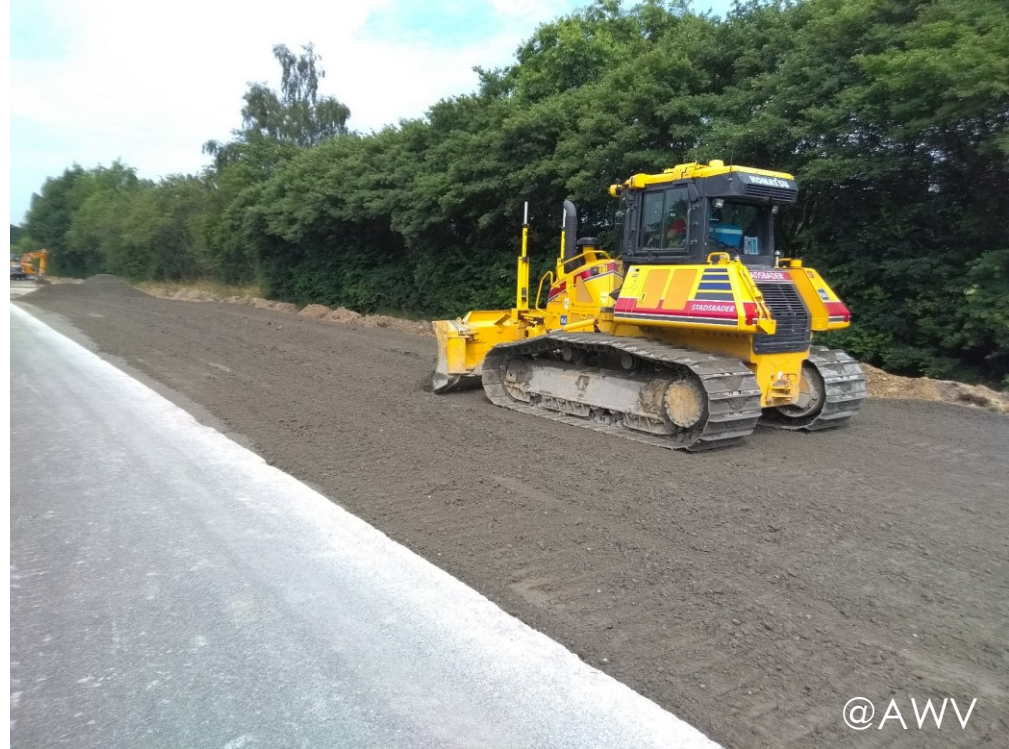
- Execution
  - Putting in place of RCC

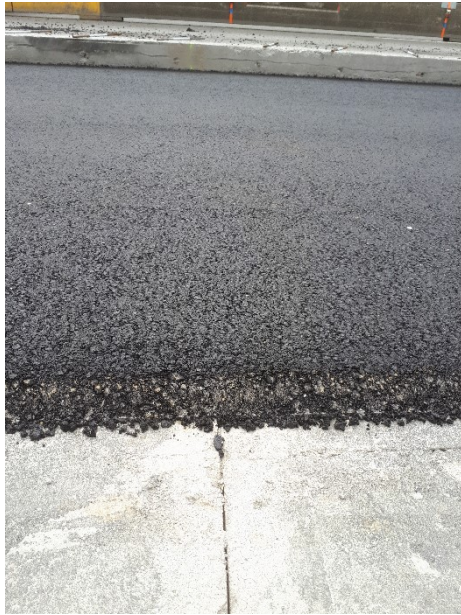
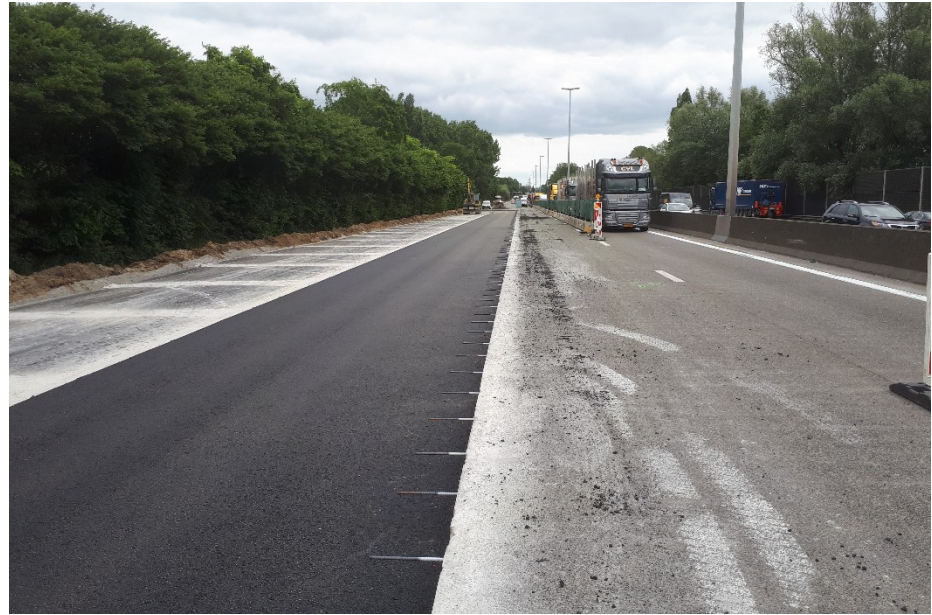
- Execution
  - Intermediate asphalt layer

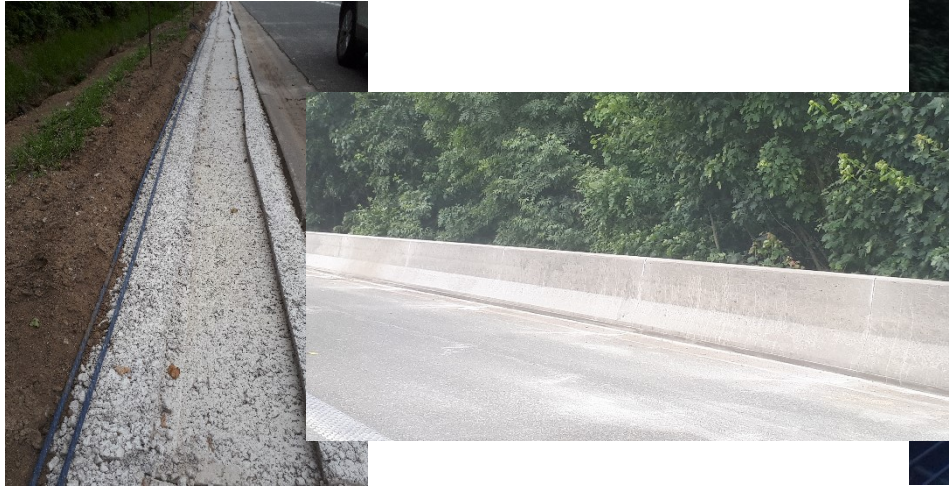
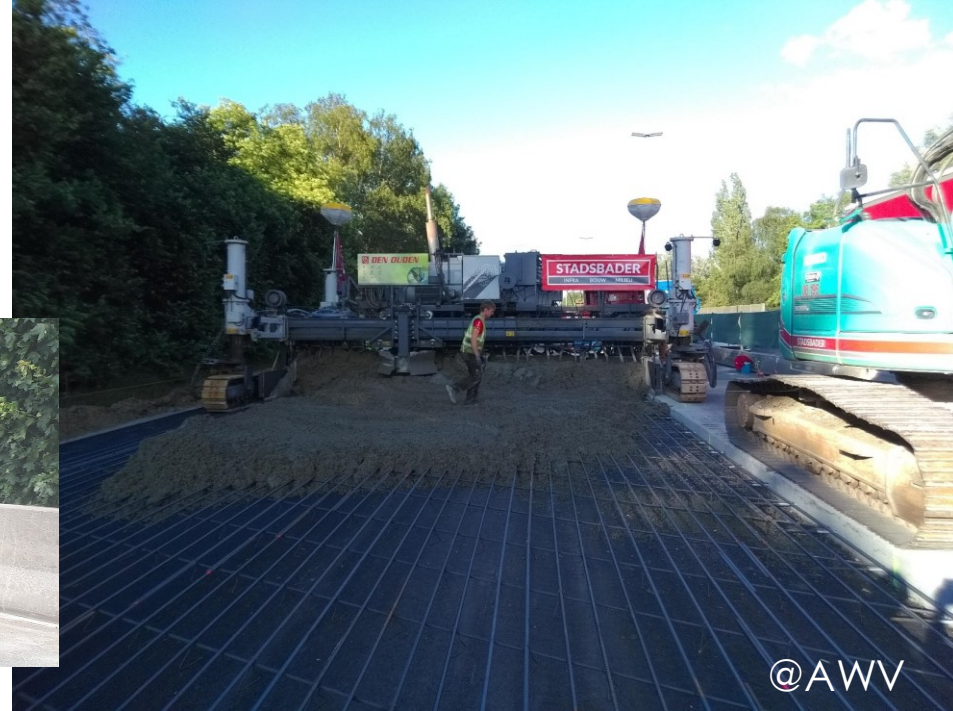
- Execution
  - Construction of concrete pavement and safety barriers (“New Jerseys”)

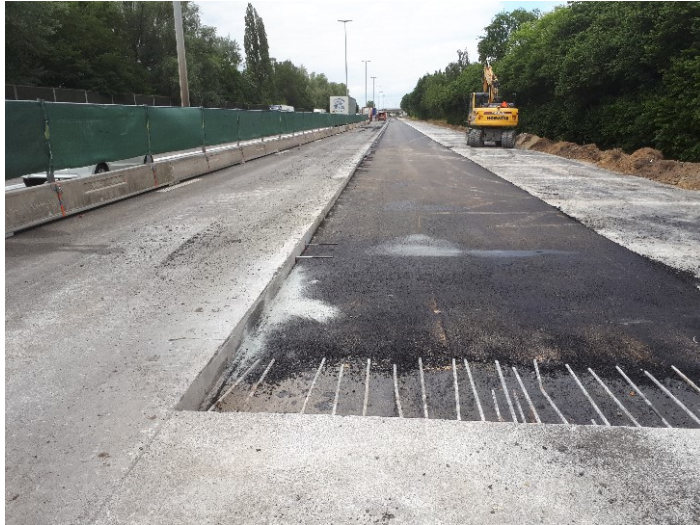
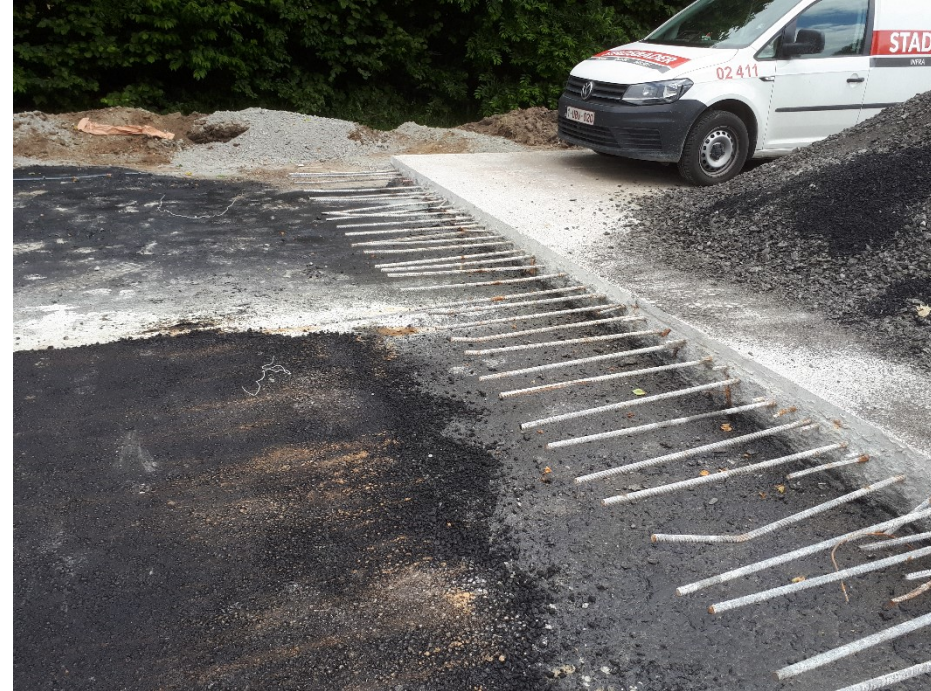
- Points of attention during construction
  - Anchorage with existing structure

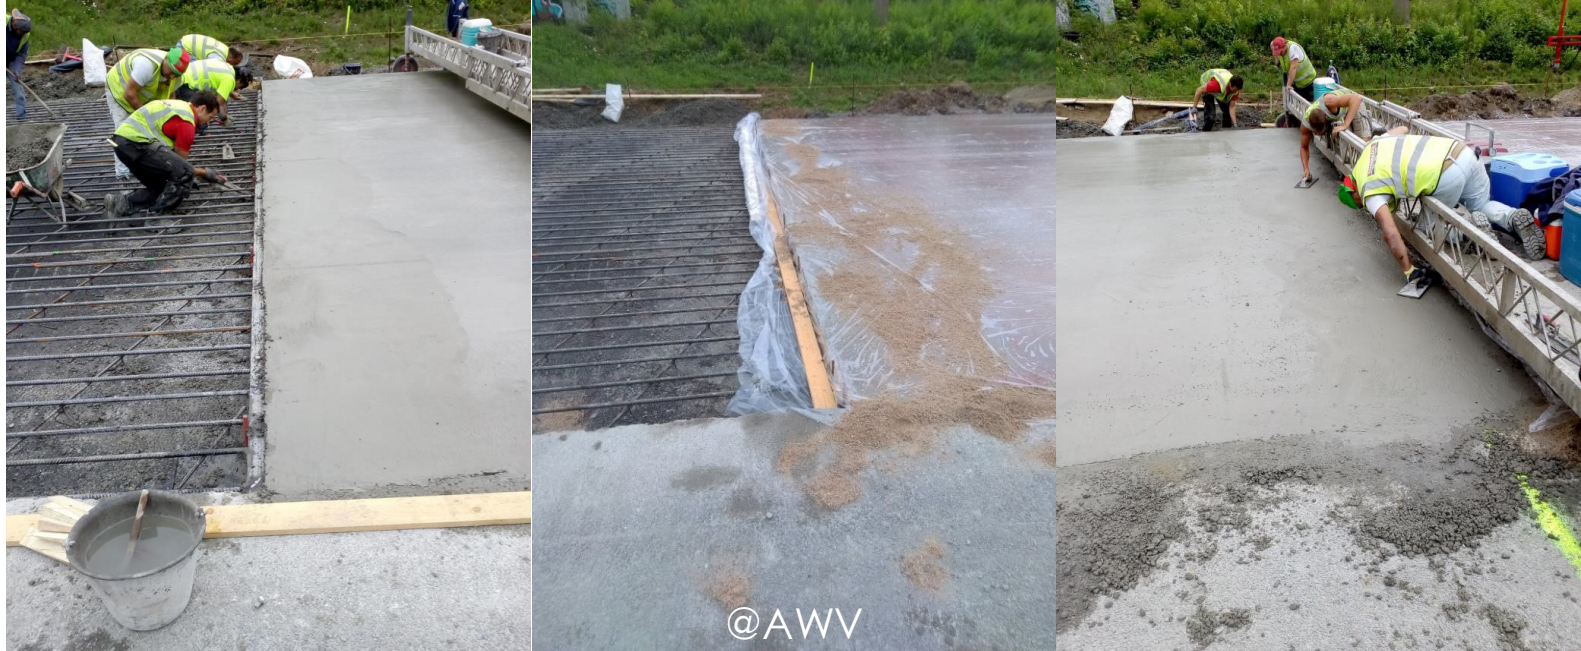
- Points of attention – construction / “day joint”
