Never too late for dowels or tie-bars

the techniques of dowel bar retrofitting and cross stitching

Pascal Buys ROBUCO

EUPAVE Best Practices Workshop

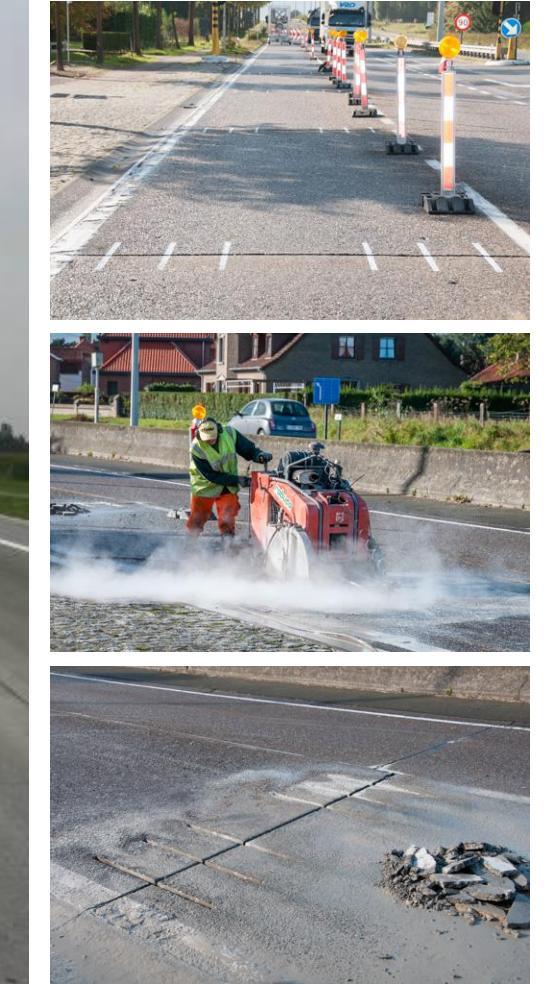
Dowel bar retrofitting at regional road N44 in Aalter

- Insertion of 3 dowels per wheel track (2x3 dowels per lane)
- All dowels must be positioned horizontally and parallel for free joint movement
- The depth of the slot is half the slab thickness + 2 to 3 cm.

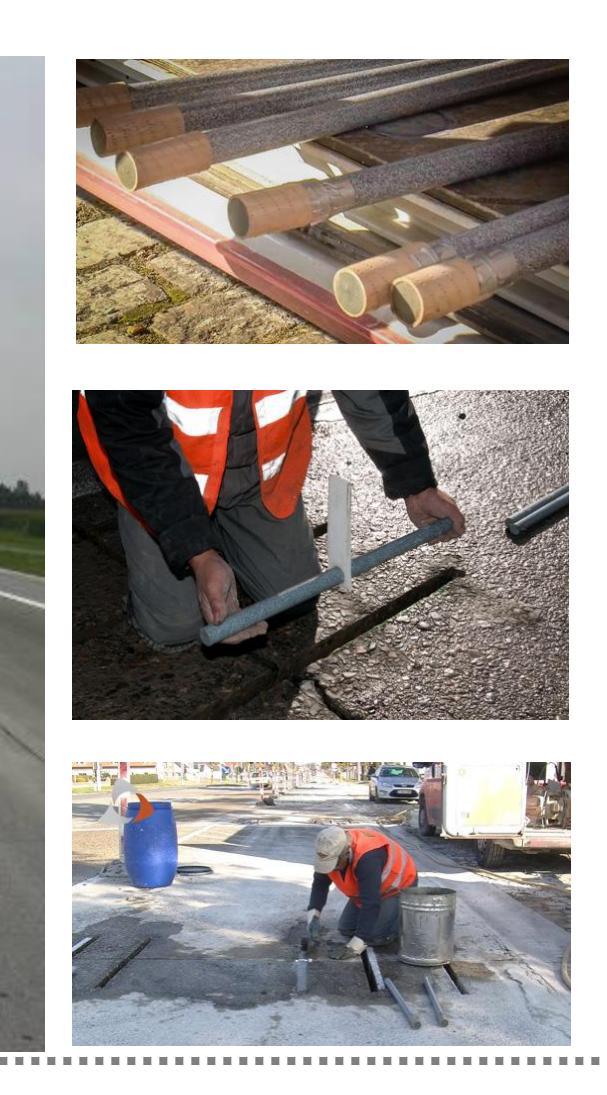
Dowel bar retrofitting at regional road N44 Aalter

- Every dowel bar must be equiped with a air cap in order to allow horizontal movement
- Avoid mortar to enter the joint in order to allow horizontal movement
- Use a high quality hydraulic or synthetic mortar with low shrinkage
- Gluing mortar with the concrete is essential

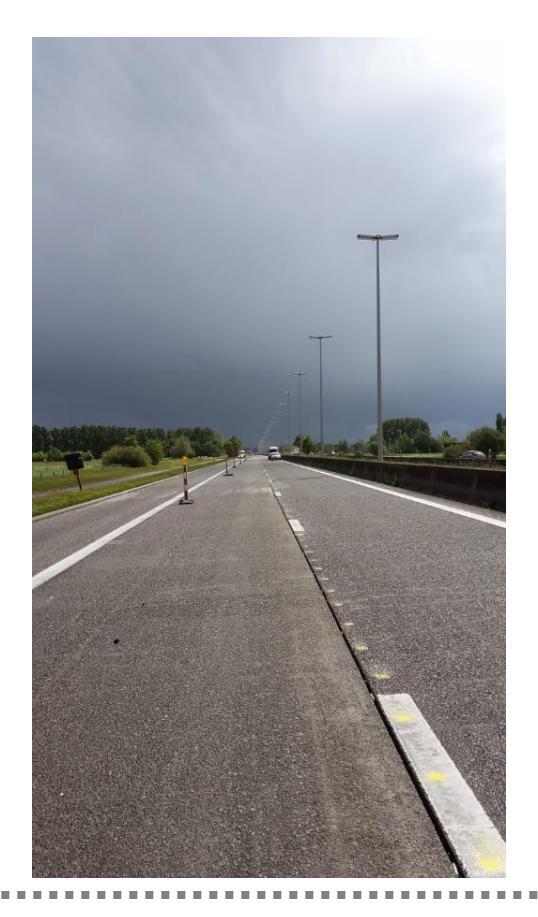
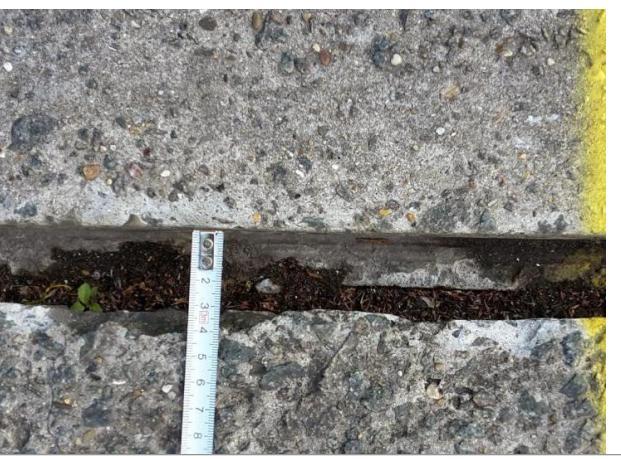
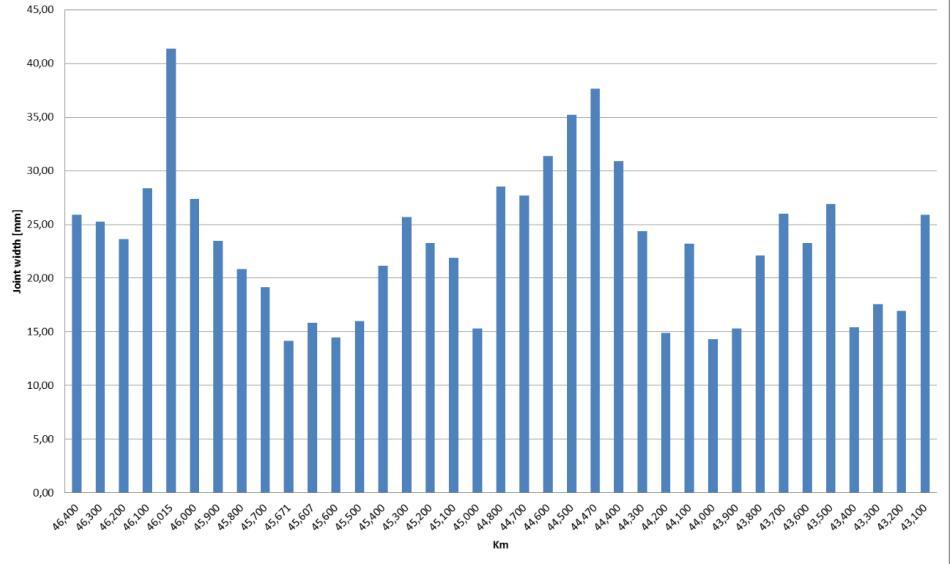
Case: E34 Antwerp-Knokke between Kaprijke and Assenede

Construction joint: Widening up to 40mm.

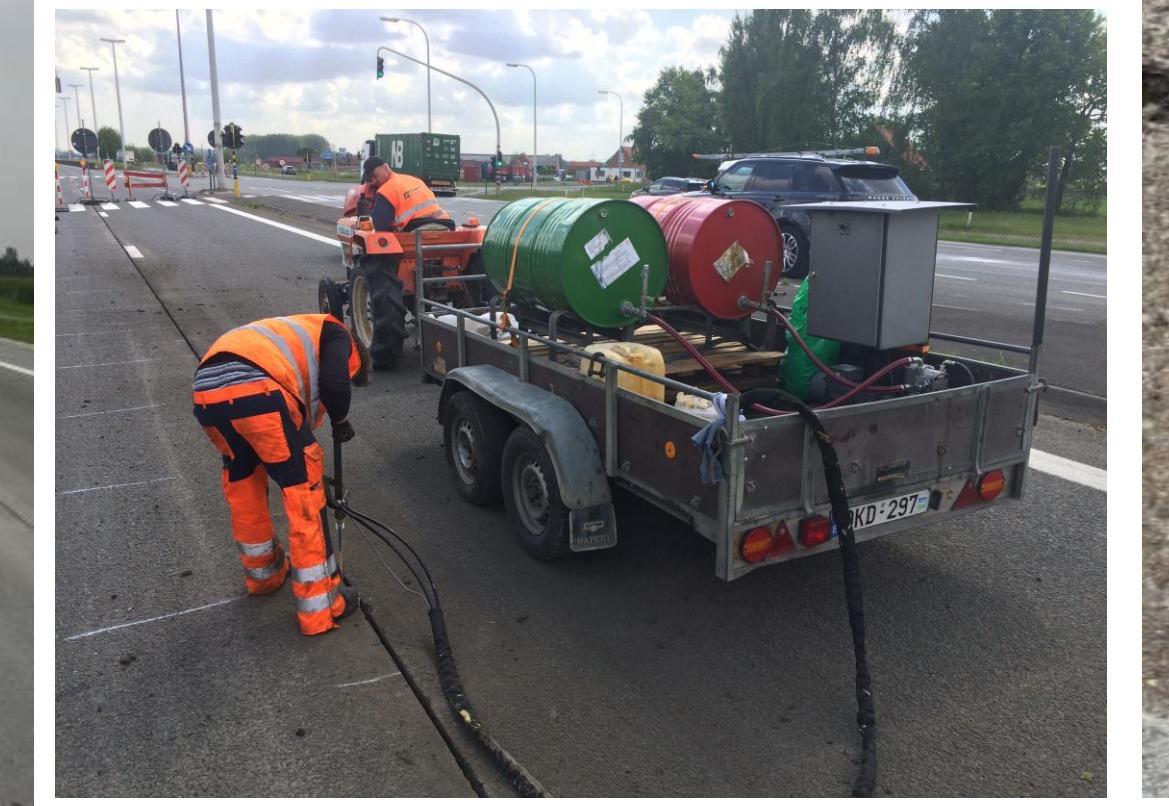
Filling the open joint with a PU dot

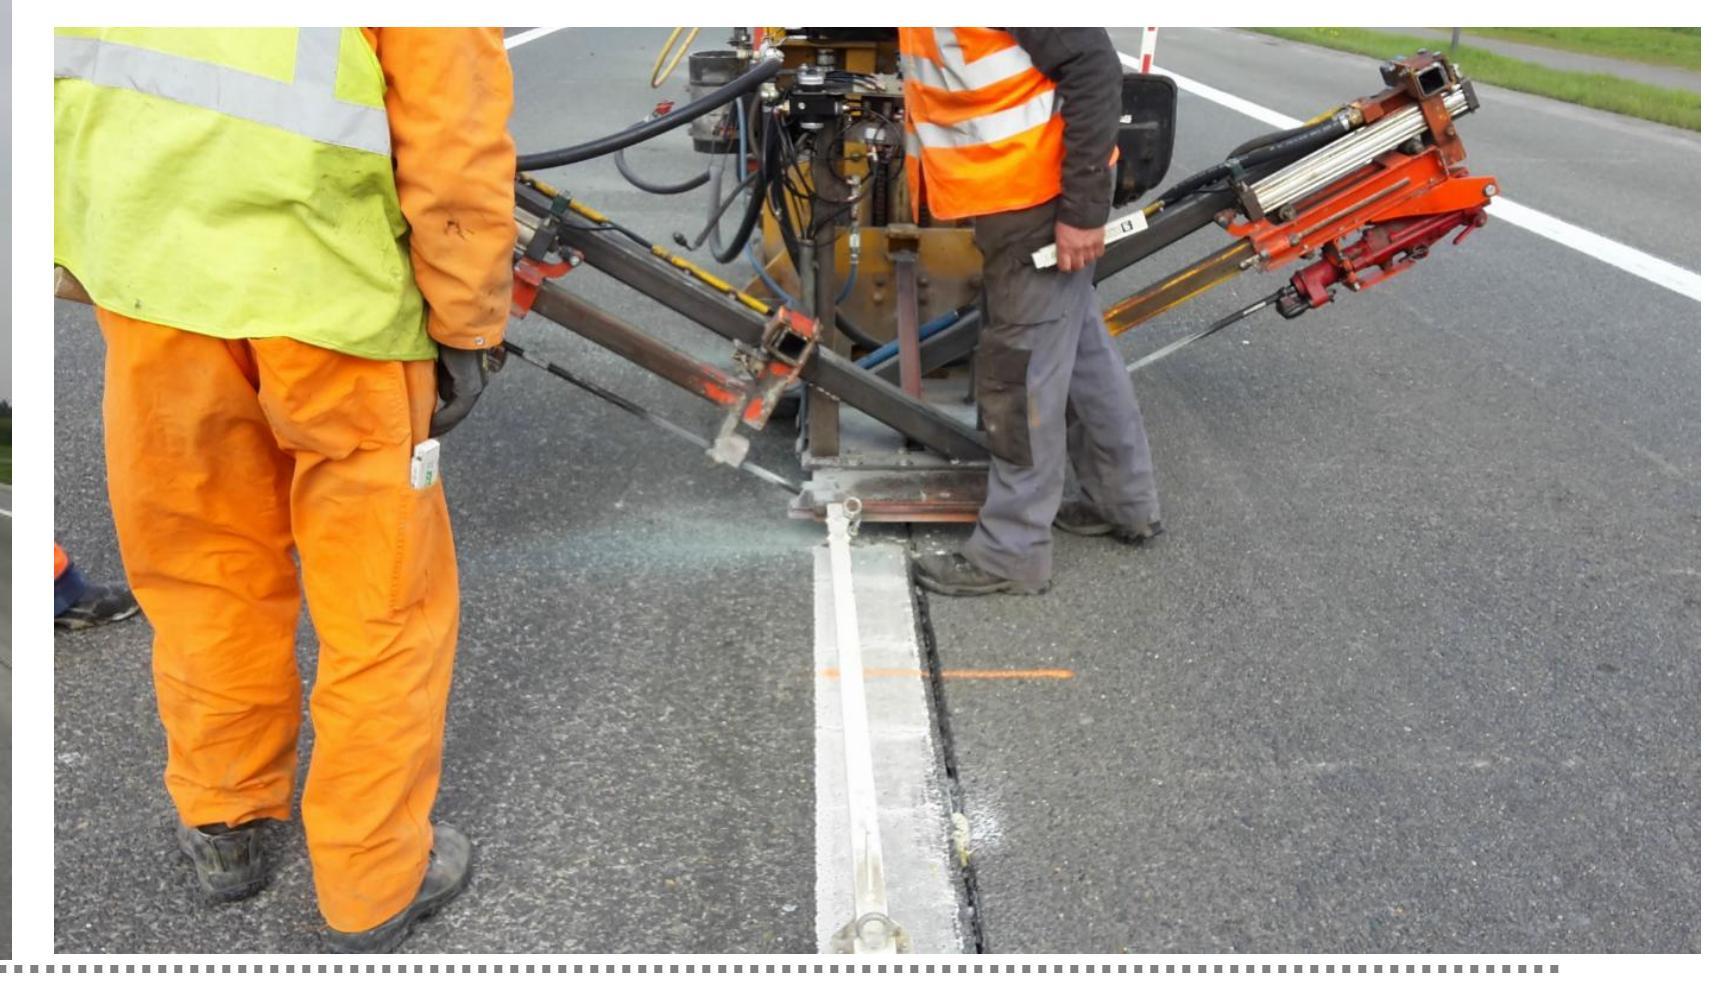
Presence of longitudinal reinforcement bar near to the edge made it difficult to drill the hole

<u>Solution</u>: Drilling only from 1 side

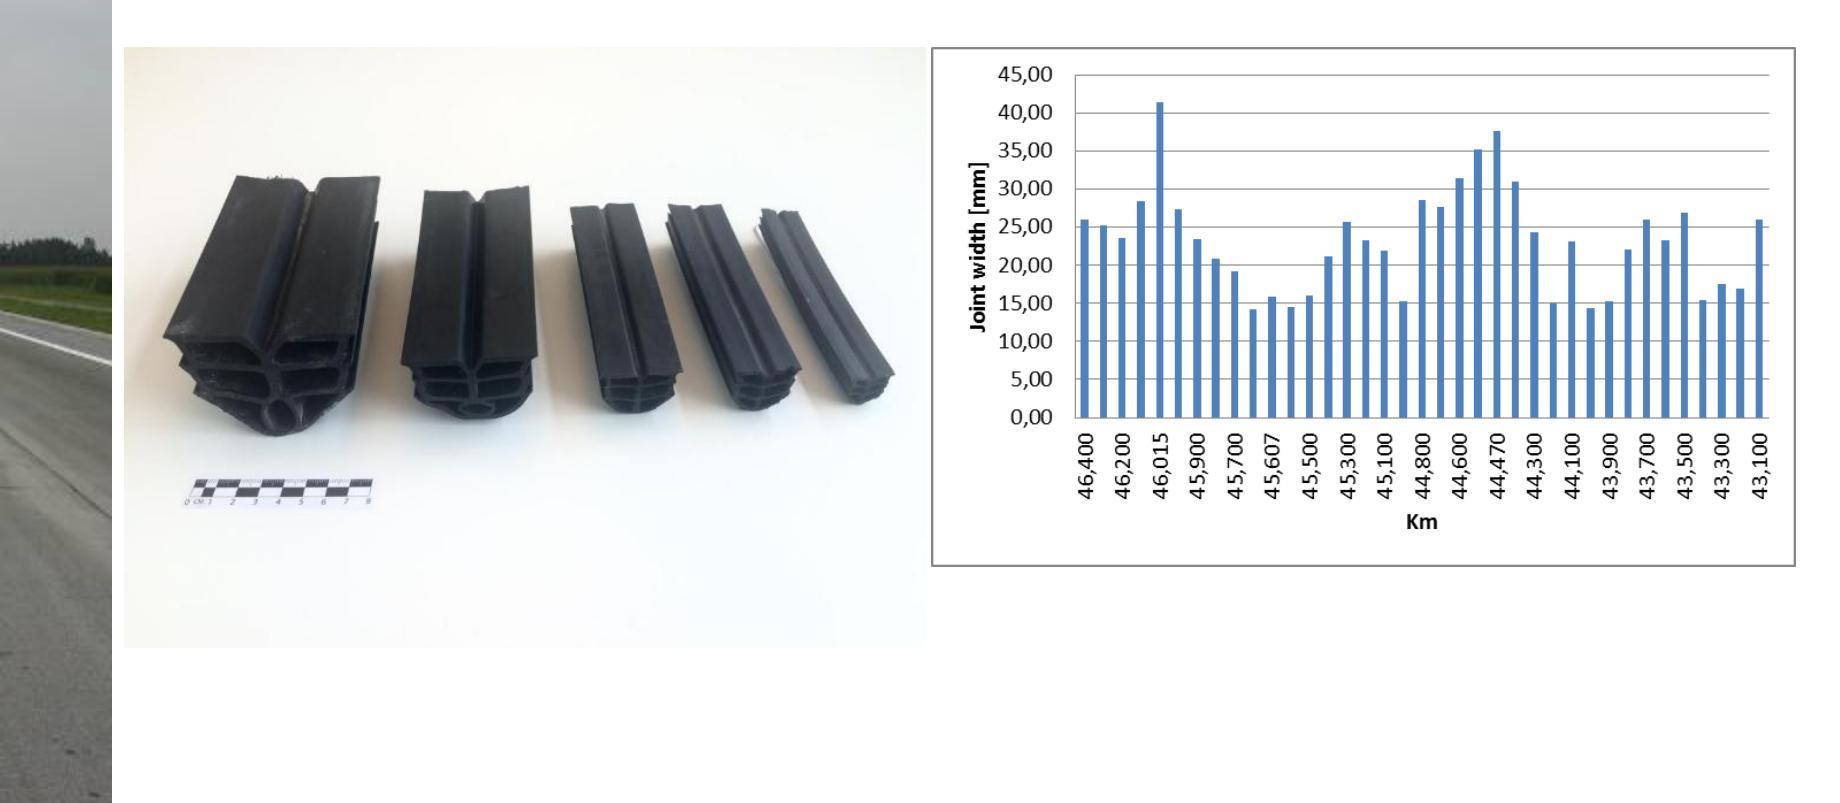
Joint filling

- EPDM extruded joint filling material in different sizes
